Seminar introductory speech

As Prefect of the Basse-Normandie Region and Prefect of the Calvados *Département*, it is with immense pleasure and interest that I welcome the 2005 international seminar on industrial accidentology and feedback to Caen, the "county seat" of the Basse-Normandie region and Calvados.

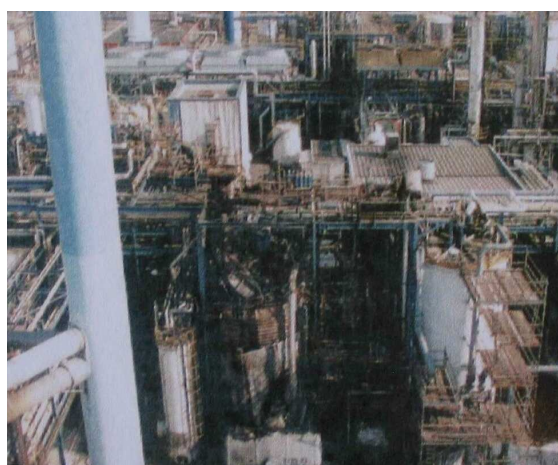
The explosion resulted in very localised property damage. The effects were observed up to twenty metres from the accident (projectiles and broken glass). The reactor had opened up (see photo) despite the overpressure protection device installed.

Overall view of the reactor

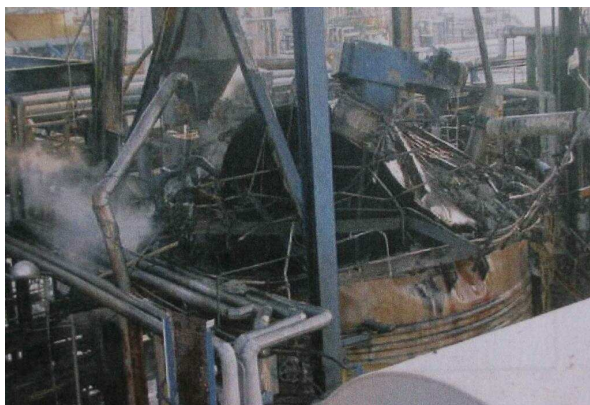
View of the damaged reactor from above

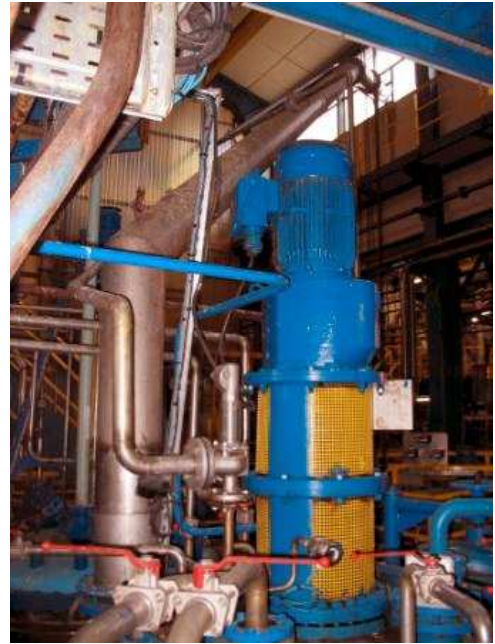
5.40 am: The newly replaced graphite burst diaphragm, calibrated at 3 bar, ruptured; 5,000 litres of reaction mixture (**soluble alkaline sulfone**) was projected outward and spilled into the 200 m² storage zone protected by retaining catchpit.

Upper part of the reactor: mixer and burst disk discharge line

As a result, the operator maintains that the probable cause of the accident was **a burst diaphragm that was calibrated too close to the reaction's service pressure resulting in its rupture by fatigue.**

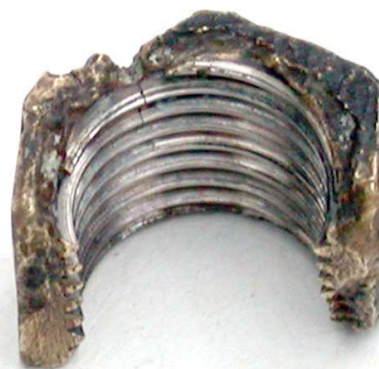
The material did not withstand the operating stresses. The nut was apparently made of chromium-plated brass, which is not ammonia-resistant (it should have been made of stainless steel). The fitting shows signs of oxidation, most likely due to the leak and the weakening of mechanical performance characteristics.

Fig. 8. Piece of the defective nut

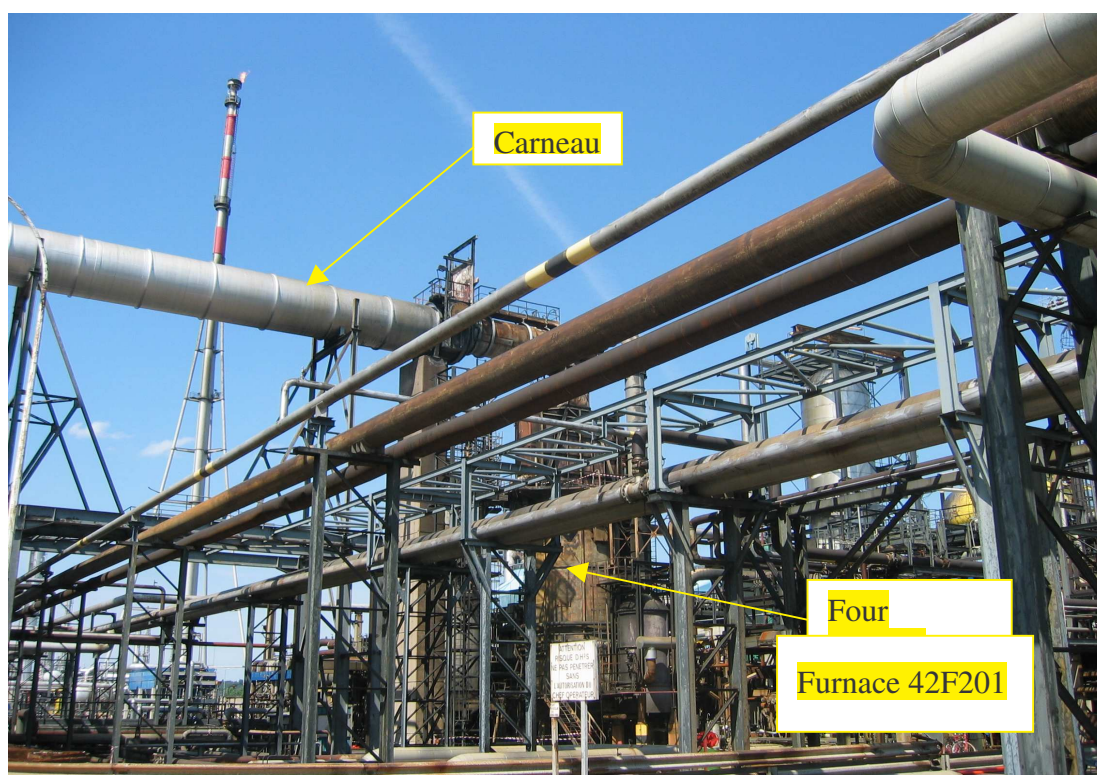
Overall view of the HDS unit (after the fire)

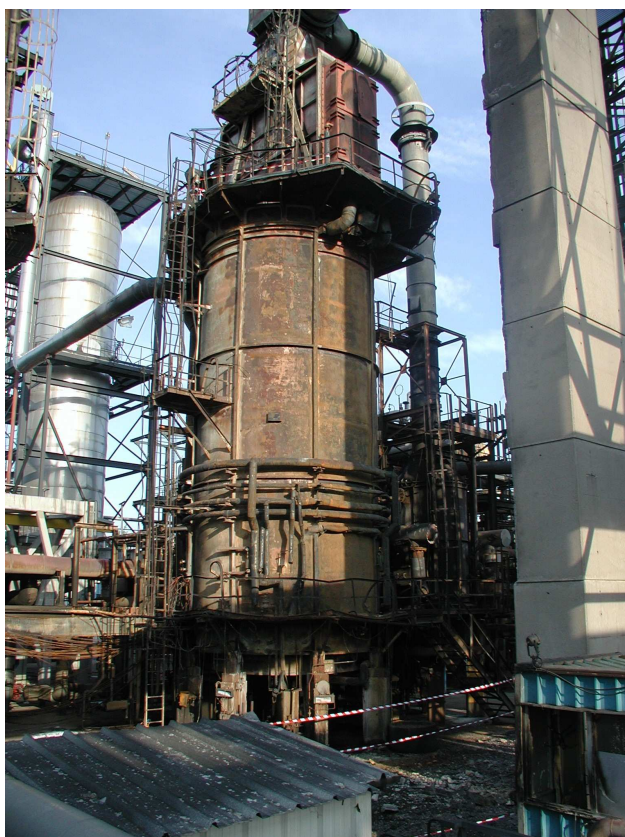
View of furnace 42F201 (after the fire)

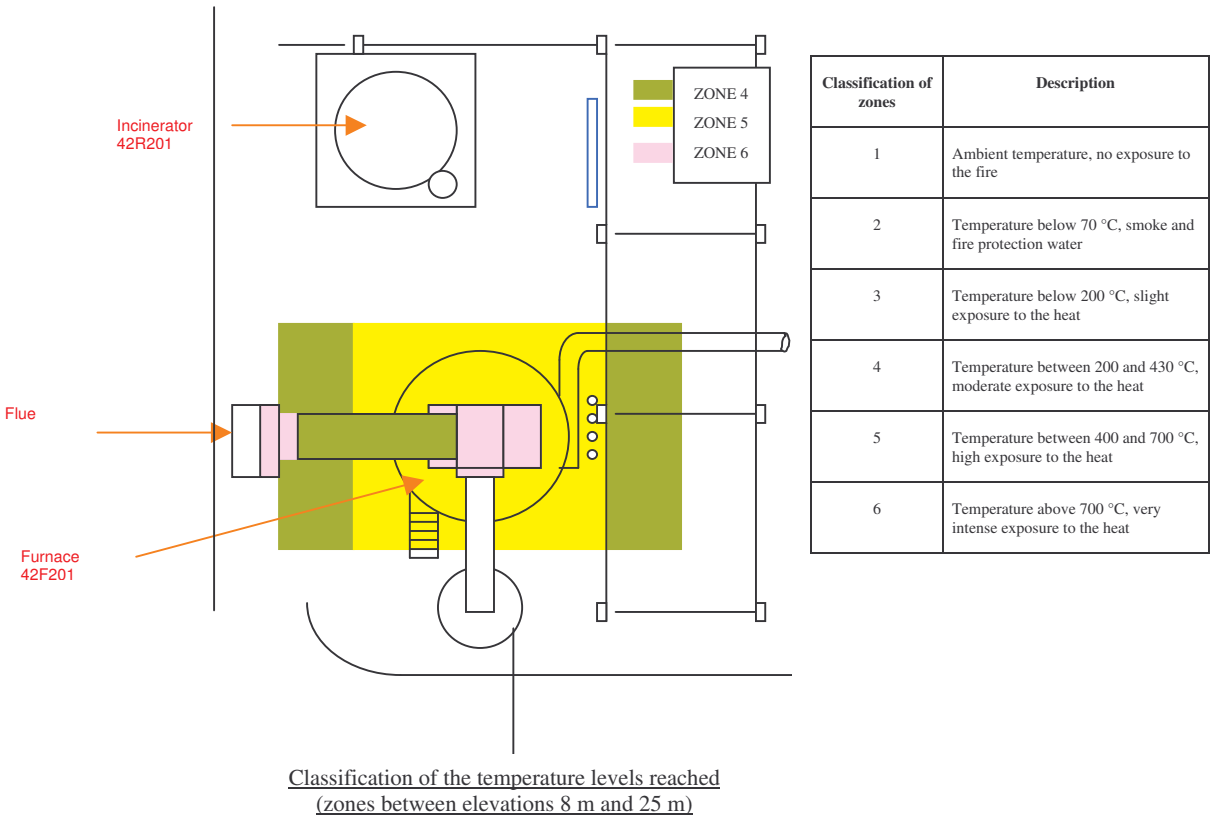
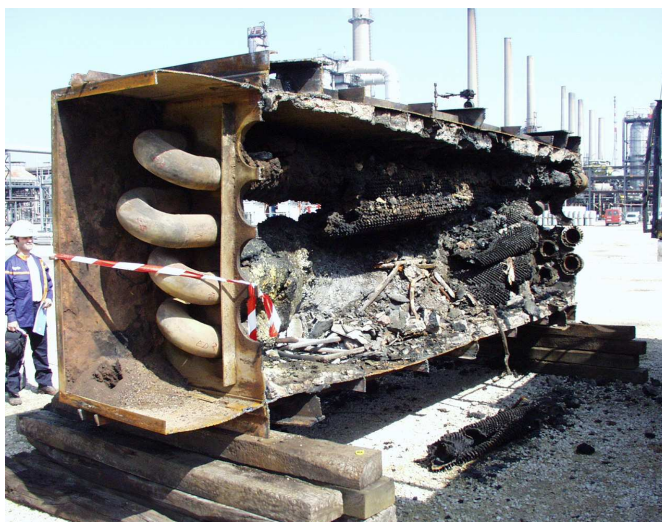
Partial view of furnace 42F201 after the fire and dismantling for inspection

- ✗ Total destruction of the convection array (fusion of the upper levels of the convection, only the lower layer had tubes that were not melted, including a burst tube) (see photo below),
- ✗ Fusion and vitrification of the refractory material on the convection part (see photo below),
- ✗ Overheating of the radiation array,
- ✗ Damage or deformation of convection and radiation wall and structural elements,
- ✗ Degradation of support columns,
- ✗ Deformation of the first section of the flue.

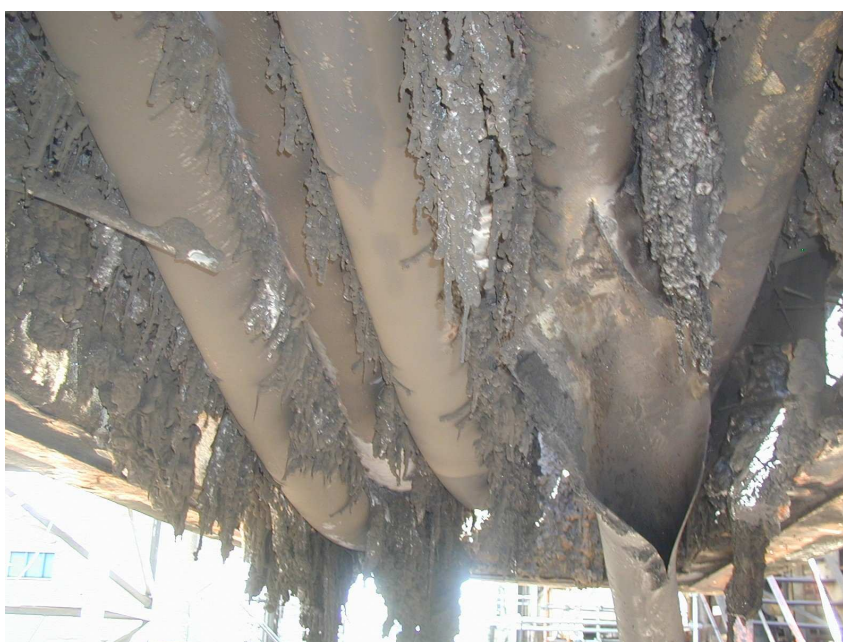
View of the lower convection layer (after the fire)

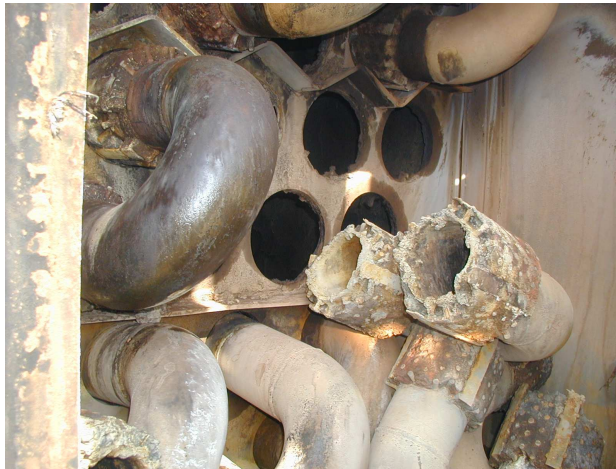
On the convection part, only thickness measurements were conducted on the peripheral elbows (see photo below), and no anomaly was recorded.

View of a peripheral elbow on the convection chamber (after the fire)

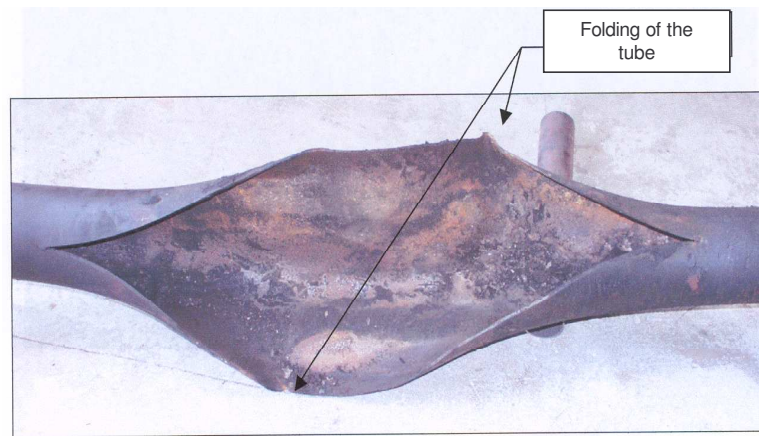
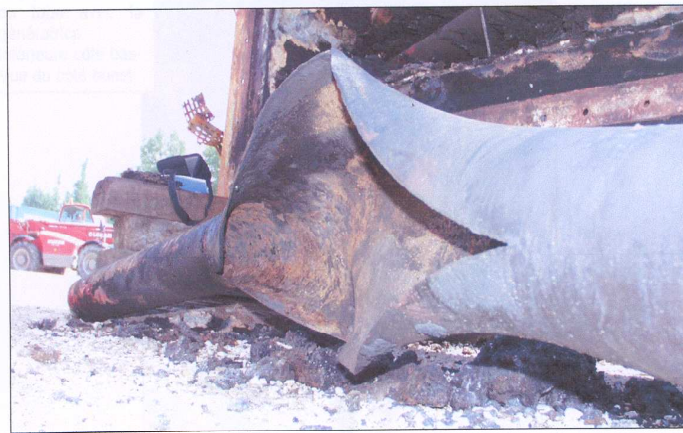
Among them, a tube that was found ruptured (a clean rupture 500 mm in length), was then determined to be the cause of the fire (see photo below).

Views of the ruptured tube

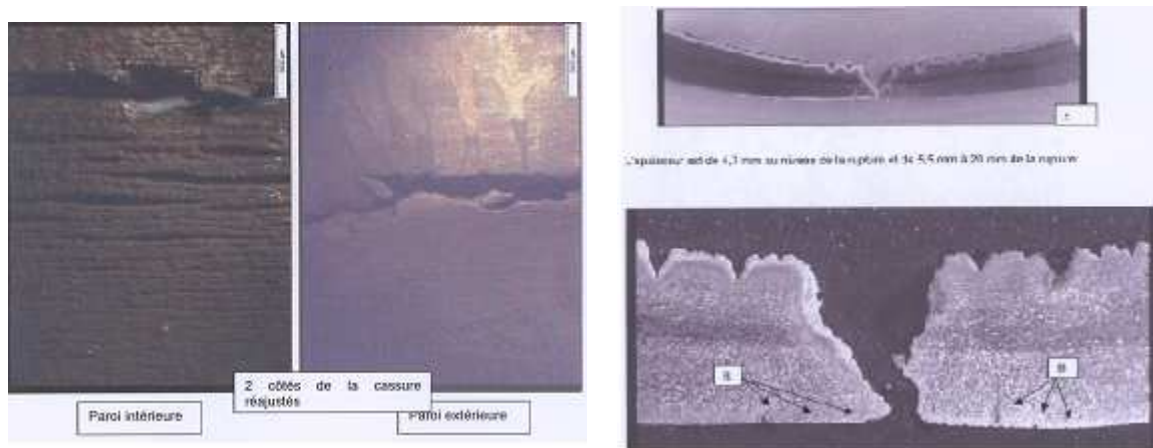
This assessment, conducted on another tube, revealed none of the internal intergranular corrosion patterns found on the ruptured tube. However, cleavage due to creep on the outside and dense sigma phase on the inside were noted. The assessment concluded that the defects were localised.

Microscopic view of the break and its two edges readjusted (burst tube)

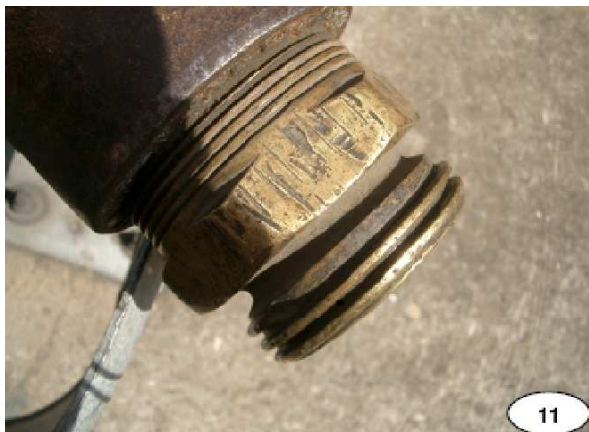
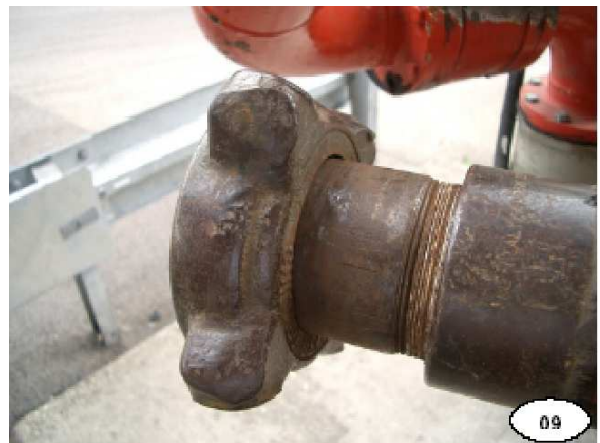
Examples of worn threaded coupling : road-tanker fitting and threaded ring
