Lessons learnt from industrial accidents 2023 Seminar

23-24 May 2023

Date of report: 12/06/2023

Report number: 2022(II)

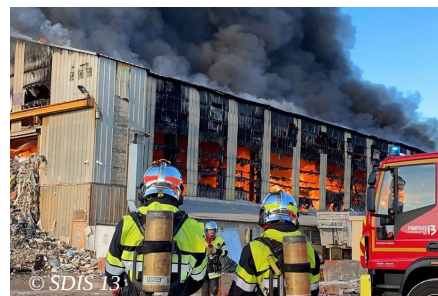
Given the large amount of waste, inaccessibility of the seat of the fire, the risk of building collapse and the inaction of the operator, the public authorities decided to demolish the building, before setting to work on the piles of waste and spreading them to reach the burning areas and water them abundantly. About 6,000 metric tons of waste (about 7,500 m³) had to be removed urgently to allow the intervention of the fire engines. The fire was finally extinguished 47 days after the outbreak. About 15,000 m³ of waste was burned.

The exact origin of the fire remains unknown. The storage conditions and volume were not in compliance at the time of the fire. The volume of waste the company reported to authorities was less than 1,000 m³, but in reality, the amount of waste stored was estimated to be 30,000 m³. The site did not have any fire protection. The operator's business activity was not insured. In addition, the operator was using a waste shredder and sifter without prefectural authorisation.

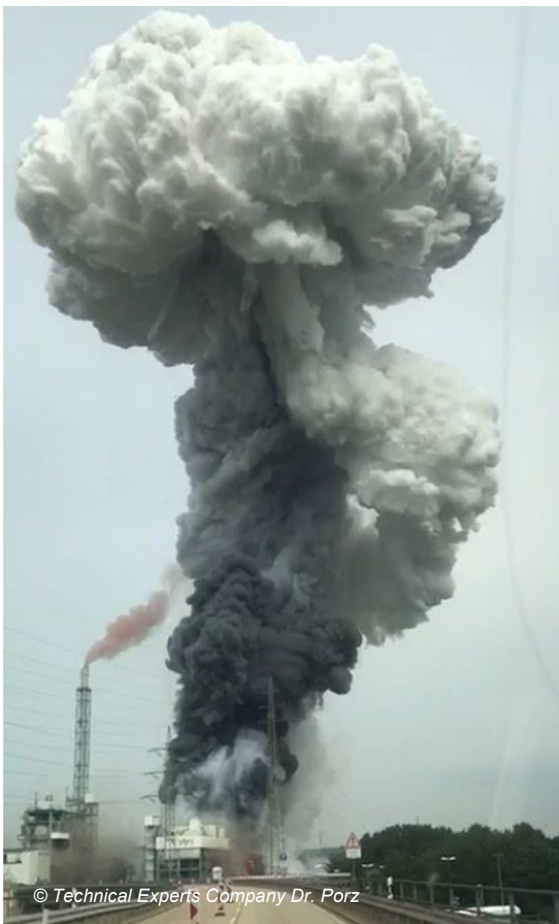
The explosion occurred in a temperature-controlled tank (50 m³) containing 16 m³ of liquid waste with organic phosphorous and sulphur compounds from a Danish pesticide production facility. The main component of the waste was O,O-dimethylhydrogendithiophosphate. The tank was filled with the waste the day before at noon. During the night, the operating staff recognized that the waste was self-heating and they tried to inject it into the incinerator but failed because of technical problems. They decided to wait until the next morning to try again. During that time, they cooled the tank from outside with water and from inside with oil but that was not sufficient. The temperature rose to 90 °C until the next morning at 9:15 am. Afterwards temperature and pressure increased rapidly, the pressure compensating valves could not level out the pressure anymore and the rupture disk of the tank was not sufficient to compensate for the exponentially rising pressure. First, the tank exploded physically, and after contact with oxygen from air, the waste cloud exploded chemically. Eight of the nine tanks in the tank field were destroyed by the explosion and the following blaze but there was only small damage at the incinerator itself.

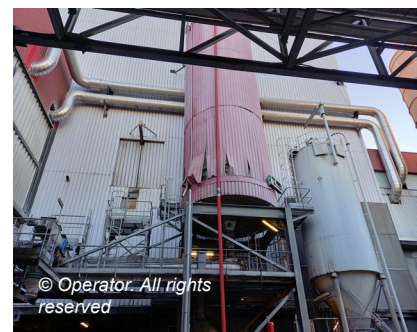
At about 6:30 a.m., at the start of unloading operations, a silo measuring 15 m in height (25 m with supporting feet) and containing 130 metric tons of RPIFW (Residues from the Purification of Incineration Fumes from Household Waste, in powder form, considered to be hazardous waste) collapsed on its base.

Damaged RPIFW silo

The silo was dismantled and cut up. The initial observations showed that the walls were thinner at the bottom of the silo, at the site of the collapse, leading to an assumption of chemical corrosion at the lower crown of the silo.

- provided evidence of corrosion of the silo steel, which did not have anti-corrosion protection (paint coating type) in the weakened area;
- noted the presence of more marked degradation on the internal surface of the silo (RPIFW side);
- also specified that the chlorine in the RPIFW could be aggressive enough, in the presence of moisture, to allow the corrosion process to begin. Nonetheless, CETIM experts believe that the rate of corrosion (determined from electrochemical measurements) cannot alone explain the loss of material observed;
- finally underscored that a thin coating (epoxy paint type) was identified on the internal surface of the silo on undeformed areas of the silo and concluded that this type of coating (which was originally present on the internal surfaces of the silo), although generally very resistant, had more limited mechanical strength (wear, for example).

The subject is about to be closed 18 months after the event. A new silo was ordered with a capacity of 200 m³ (instead of 300 m³ for the old silo) and special anti-corrosion and abrasion-resistant coating. It should be delivered and installed in March and April 2023. However, discussions are still ongoing between the operator and the inspection team about the heat insulation that the operator is again planning around the silo.

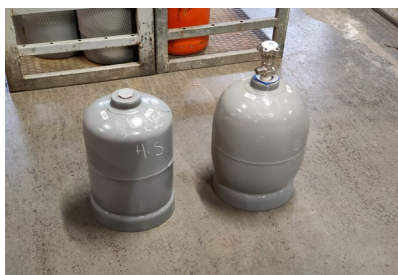
The explosions were due to overpressure during the inflation phase of the test, resulting in the bursting of the steel cylinders. The operator in charge of the test connected 4 low-pressure cylinders (LP, 22 bar) to the high-pressure cylinder filling system (HP, 200 bar) for the nitrogen leak test. After a few minutes of pressure increase, 3 cylinders exploded and a fourth deformed.

Normal (left) and deformed LP cylinders after leak test (right)

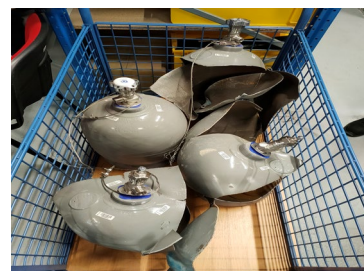
LP cylinders after the accident

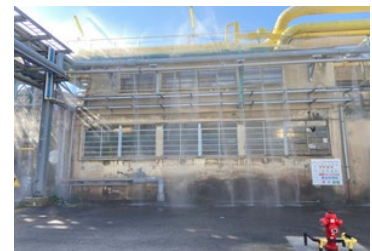
Operational water curtain

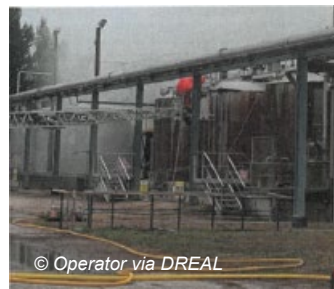
Emergency actions
