# Reinforcement Programme on inspection skills according to Landfill sites in IMPEL Member Countries

## (HOLLAND) Zaandam 16-18 November 2016

The landfill 'Nauerna' in Assendelft was selected to test the checklist.

Name of the installation: 'Afvalzorg, location Nauerna' Landfill and Waste treatment plant.

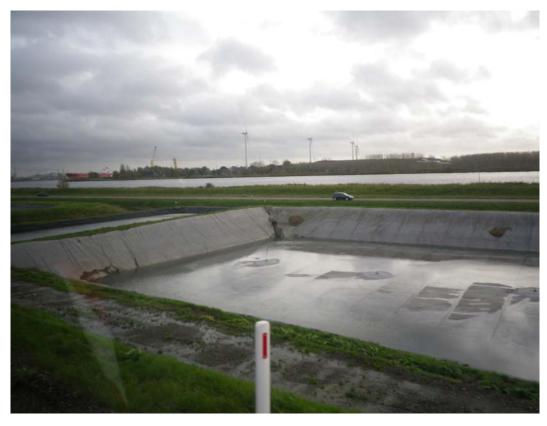
Fig.6: Covered leachate-basin

The leachate is extracted by both horizontal and vertical tubes. The pumps are located at the bottom of the cell in order to prevent weak points in the liner. The leachate basin was covered with a floating cap to prevent odour emissions.

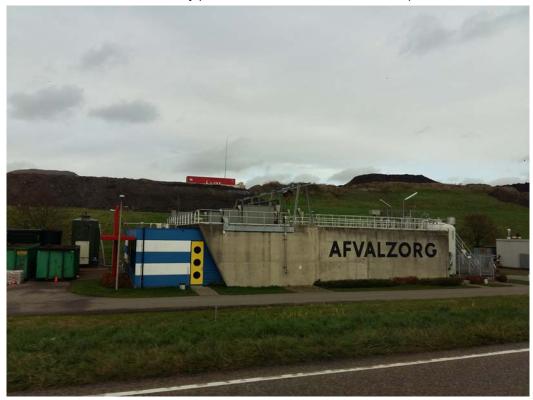
Fig. 8: Wastewater treatment-facility, aerobic treatment

The leachate, as well as the meteoric water were treated in an in-situ plant; the main pollutant to be removed is the ammonia, that is widely present in the contaminated soil disposed in the landfill.

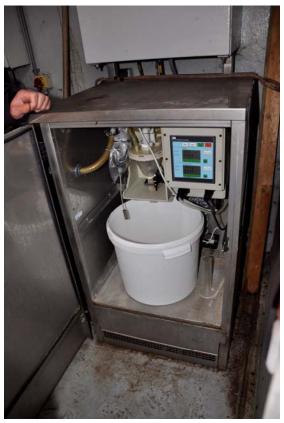
Fig.9: Wastewater sampling

The operator has to monitor the quality of the discharged water by means of a sampling machine that can be programmed to take samples proportional to the flux of the water.

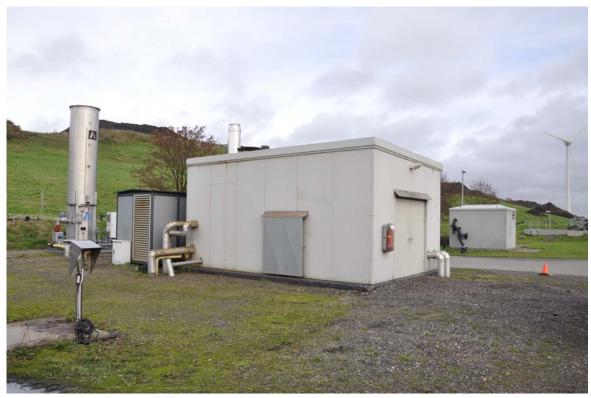
Fig.10: Biogas extraction unit and flare

The extracted biogas is used in a boiler to produce hot water that is both used internally and sent outside. A torch is present to flare the exceedance. All the process parameters are continuously monitored (flux, temperature, gas composition, pressure),

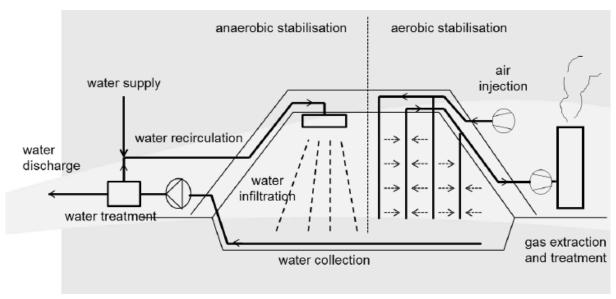
Fig. 12: Principles of pilot

Actually, the operator is testing the so called "aerobic landfill", where a temporary permeable cover is used instead of a sealing final capping, to allow water and air to flow in the body of the landfill, thus increasing the stabilization of the mass of the waste.

This pilot started to try to make the landfill completely non-reactive. To establish this situation parts are not covered to let rainwater in, leachate is put back in the landfill and aeration will also be applied. The intention is to stabilize the landfill in a shorter time, so no gas or leachate will leave the landfill.

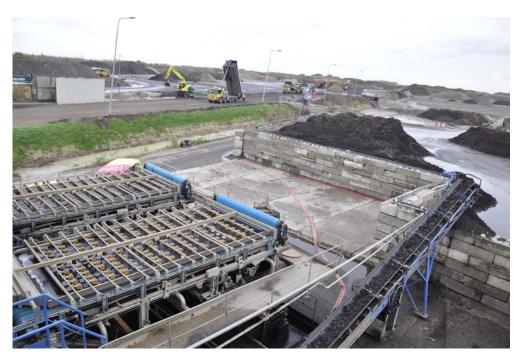
Fig. 14: Soil treatment facility

Soli is treated in a wet treatment-facility. By sifting and adding water the contaminated soil is separated in different grain-sizes. The big parts are used as road building material, additive in concrete, according to criteria set in the laws. The smallest fractions contain the contaminants and this material is landfilled. The process water is recirculated and integrated.

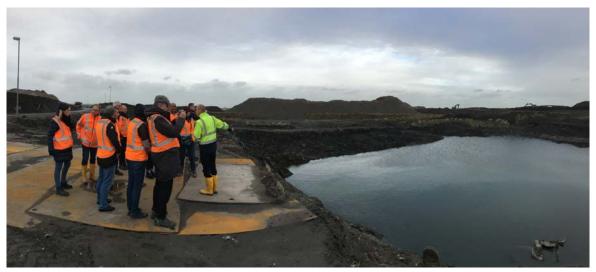
Fig. 15: Inspection at dredged sludge-basin

Dredged sludge is put in basins to de-hydrate. By dehydration usually most of the contaminants are drained from the sludge. After sampling and testing it is determined what re-use is possible. In most cases it can be used as clean soil and the water can be reused in the soil washing process.

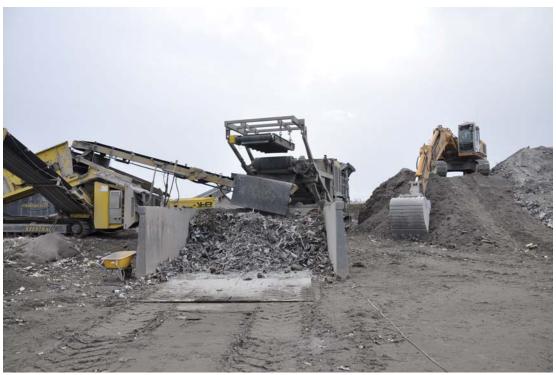
Fig. 16: Bottom-ash treatment

Bottom-ash is treated to remove above all ferrous and non-ferrous metals. Iron is recovered by means of strong magnets. Non ferrous materials are separated in different grain sizes (roughly 40% stone, 40% aluminium, 15% copper) that are sent externally to a treatment plant to recover copper and aluminium. The stone part can be used as road construction material. A pilot plant is present in the installation to have a more efficient cleaning of the bottom ash and reuse it, according to a new recent law, as a construction road material without the necessity to be insulated in the lower layers.
