# LESSONS LEARNT from INDUSTRIAL ACCIDENTS

# 10<sup>th</sup> SEMINAR

29 and 30 May 2013 – Strasbourg

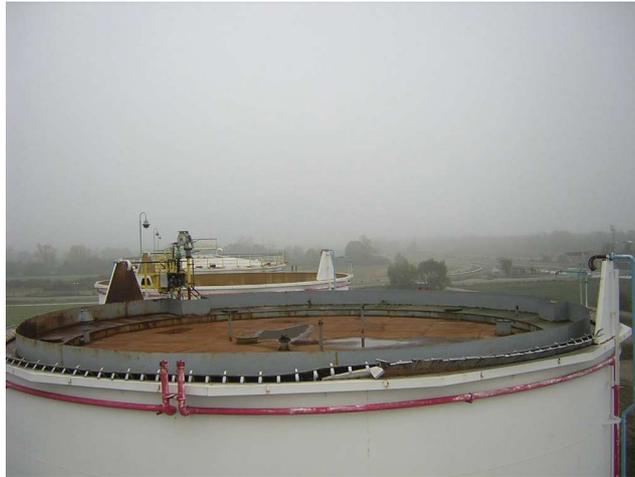
No victims were reported from this accident. Property damage was limited to the floating roof, which remained stuck to the upper edge of the tank shell. After several hours of investigation, the gasoline loss could be evaluated at approx. 20 m³. The gasoline was eventually recovered and routed to a slop tank (i.e. containing liquid residue) for treatment.

Due to its malfunction, the second "MIP" system failed to sound the high-high level alarm. The tank overflowed and gasoline spread towards the tank's outer ring, eventually reaching the oily water network, since the purge valve had remained open. This open valve position was a measure practiced during periods of heavy rainfall in order to avoid clogging the outer ring and to ensure good working order of the drain on tanks fitted with a floating roof.

Figure 4: View of the tank's floating roof after the overflow (source: Site operator)

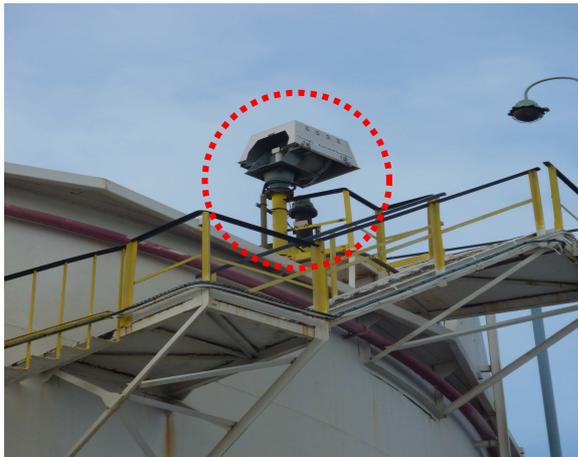
- The vertical shaft on the radar-based system for verifying operating levels (Fig. 6) was not equipped over its height with orifices to allow for unrestricted flow of gasoline into the tube. This shortcoming led to a false reading of gasoline level in the tank due to the presence of heavier water; the level read by the control operator in the control room was therefore actually lower;
- The high-high level barrier (MIP system) was inoperable despite recent verification. The vertical measurement shaft on this sensor contained orifices over the longitudinal generatrix, allowing gasoline to pass and thereby eliminating any risk of false reading due to the presence of water heavier than the product.

Figure 5: View of the radar device on tank T 495 (source: DREAL-ALSACE)

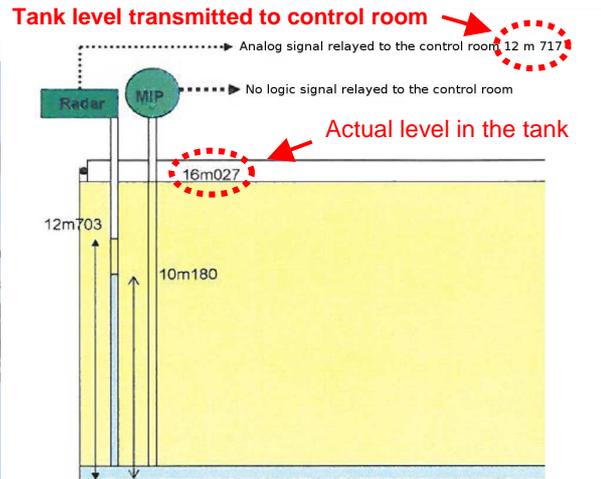
Figure 6: Presence of water in the control shaft of tank T495, observed after lowering the floating roof (source: Site operator)

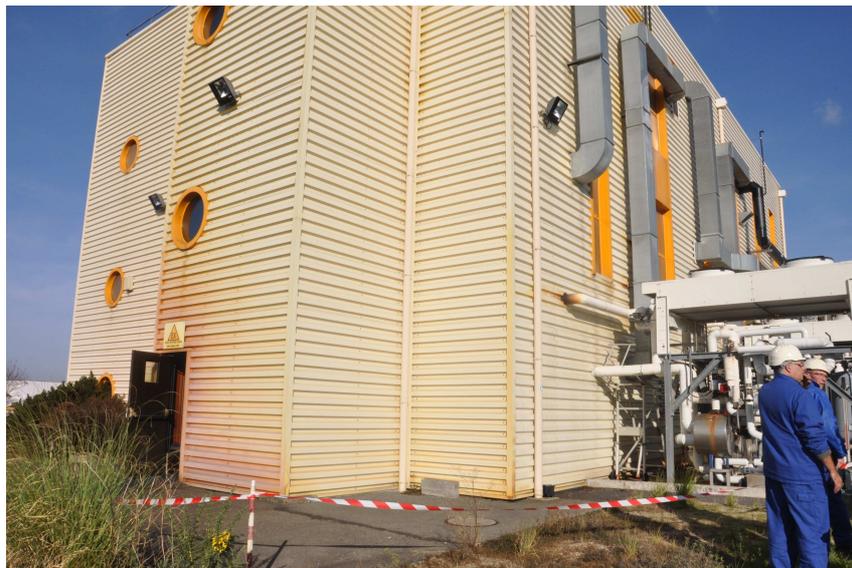
The initial mass of wet DICOA (solvent = water + ethanol) present in the dryer amounted to approx. 1.8 tonnes, i.e. on the order of 1.4 tonnes of dry DICOA. A portion of the decomposed product remained in the dryer (about one-third of the initial mass was found inside) and in building B45, whose walls, floors and ceilings had been covered by a pinkish deposit. The quantity released outside the site could not be accurately determined.

*Traces of reddish deposit on building B45 - Source: DREAL Environmental Agency (Brittany)*

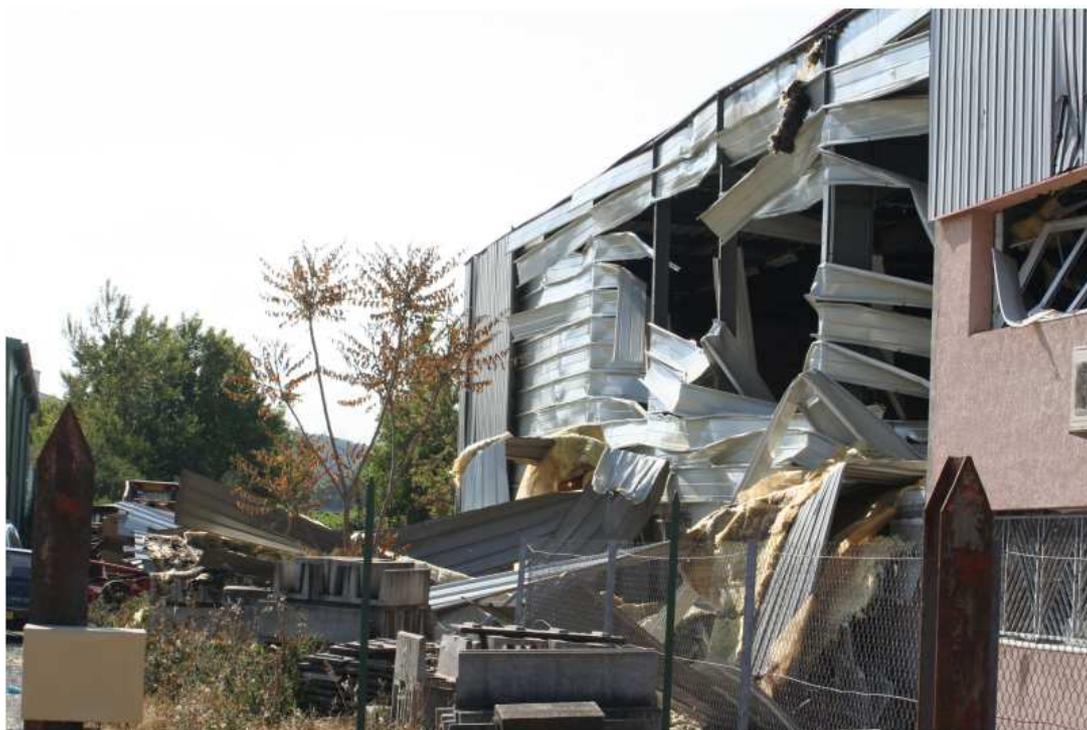
Damaged building - All rights reserved

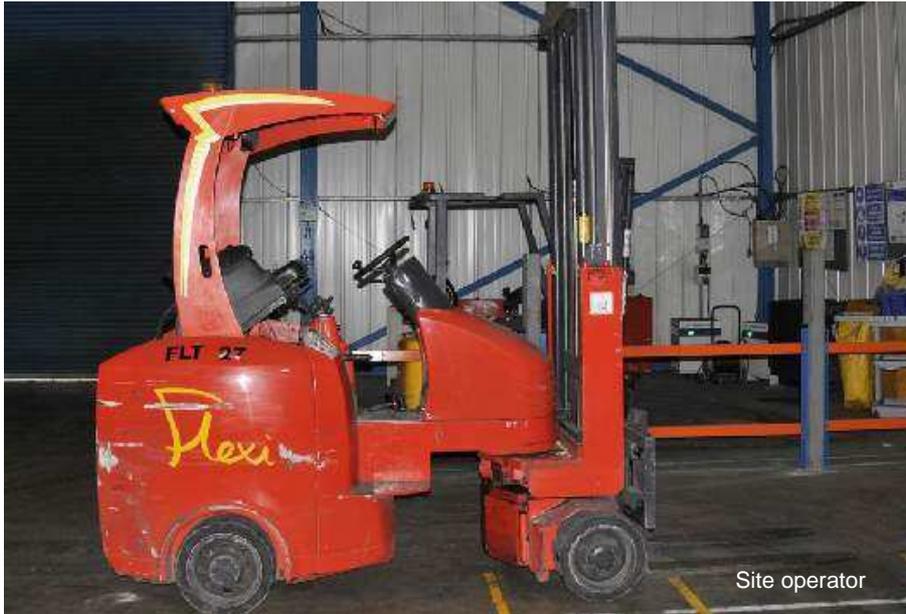
Figure 2: Unprotected electric flexi-truck in use at the site

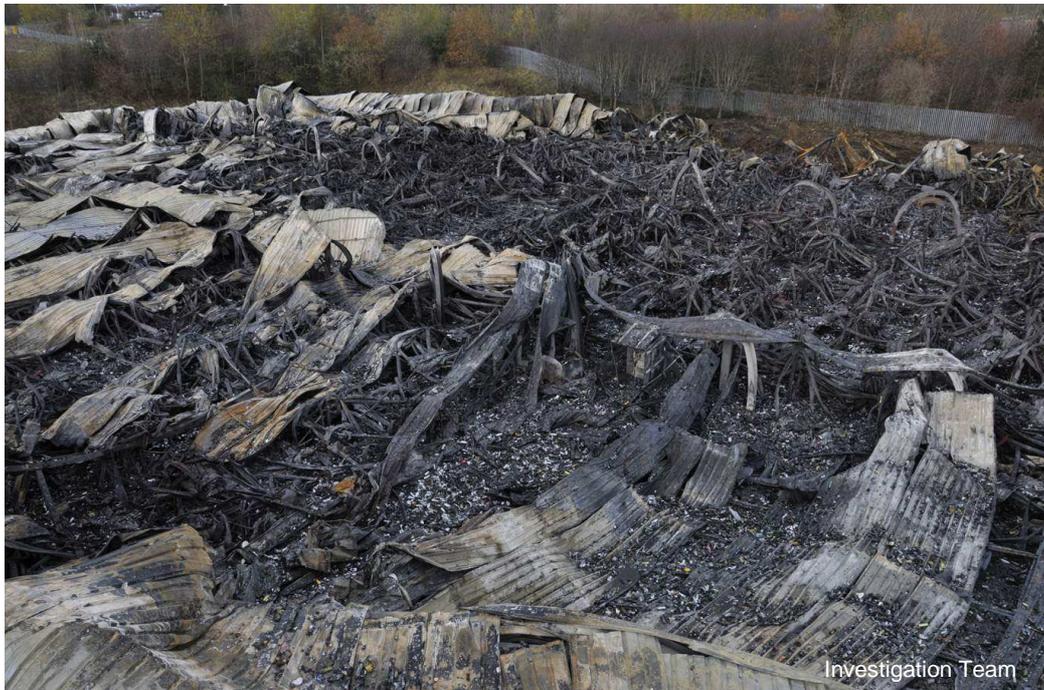
Figure 3: Damage to the warehouse and contents caused by the fire

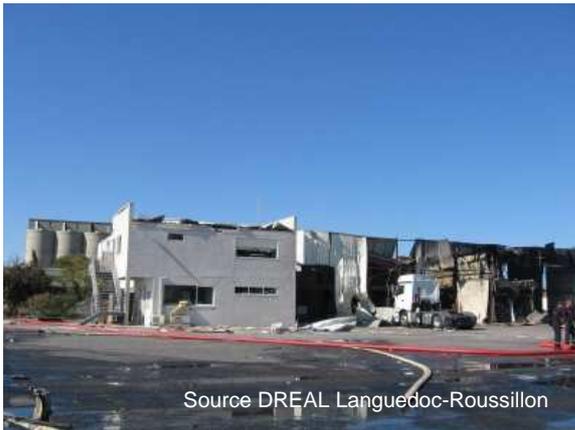
Source DREAL Languedoc-Roussillon  
*Administrative offices and maintenance shop: concrete structure shifted due to the blast*

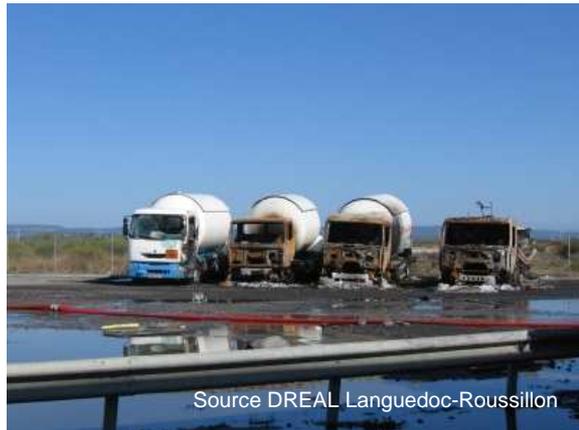
Source DREAL Languedoc-Roussillon  
*Zone occupied by gas tanker vehicles: burned lorries*

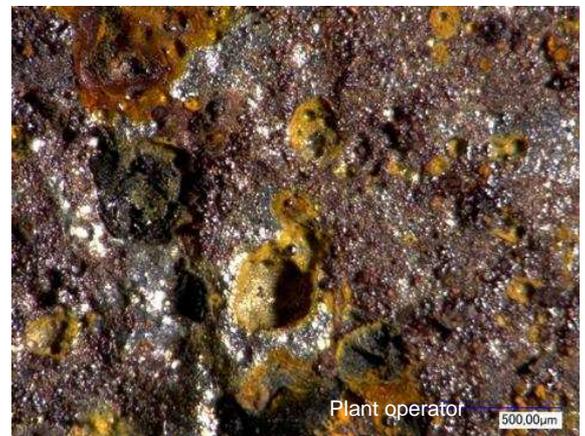
The presence of phosgene and residual water under the deposits led to the formation of hydrochloric acid.

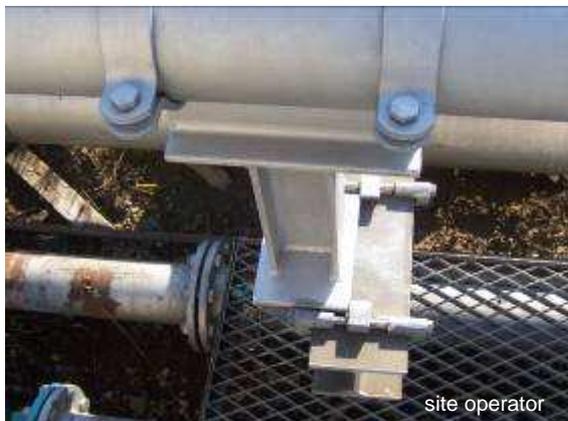
Dislodged pipe bracket

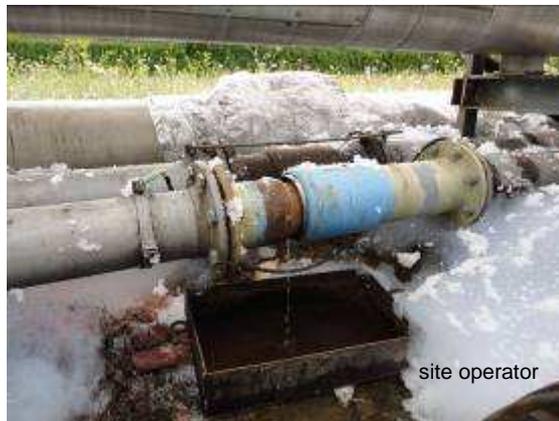
Damaged expansion compensator

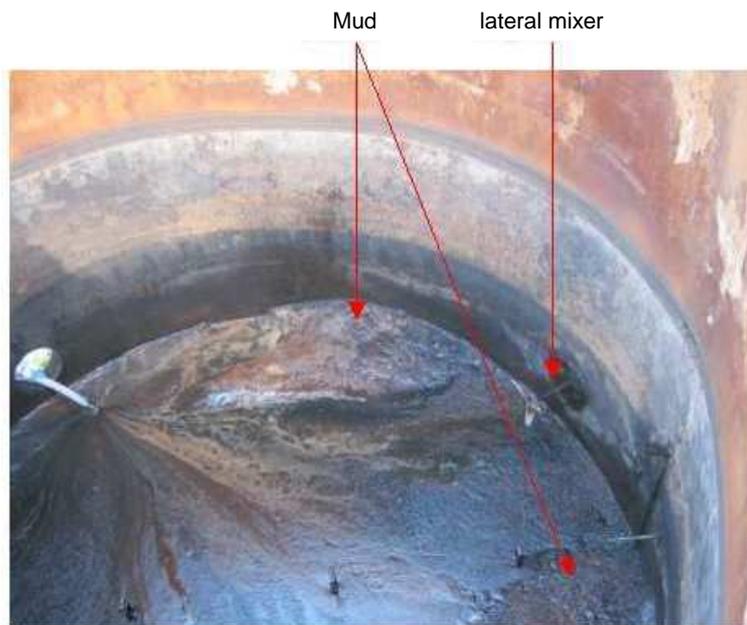
Fig. 11: TKX after emptying in December 2000 - solid residues collected from the bottom (source: operator)

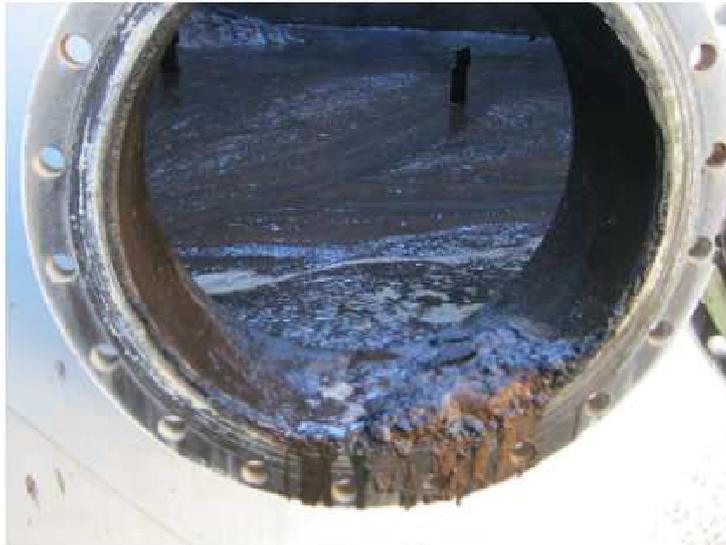
Fig. 12: Solid / paste residues collected from the exit nozzle (source: operator)
