Seminar introductory speech

As Prefect of the Basse-Normandie Region and Prefect of the Calvados *Département*, it is with immense pleasure and interest that I welcome the 2005 international seminar on industrial accidentology and feedback to Caen, the "county seat" of the Basse-Normandie region and Calvados.

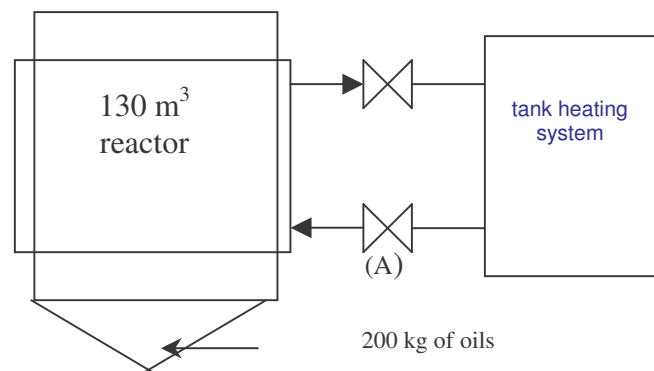
- temperature rise tests were being conducted on the reactor's heating system,
- the reactor was not disconnected from the heating system. The inlet valve (A) on the reactor's heating coil remained open,

- the atmospheric temperature of the reactor thus increased and caused the mineral oils in the bottom of the reactor to evaporate and decompose,
- the unit's monitoring parameters were reported in the control room although no specific action was taken by the operators as the unit was shut down and the production personnel did not consider that the unit presented any danger, a priori.

- the temperature of the thermal fluid had reached 250 °C,
- the atmospheric temperature remained around 200°C for many hours with a sudden increase in temperature just prior to the explosion. This was not noticed in the control room as the temperature alarm was set above 300 °C only for "product quality"-related questions (handling of non-flammable products).
- The valve of the heating coil had opened when the boiler was made available (according to the procedure) but had to be closed when the heating system of the tanks was restarted.

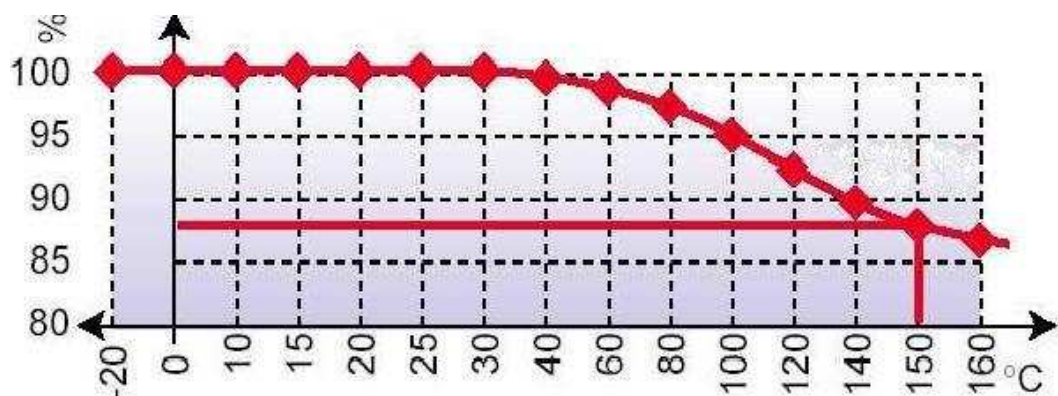
- **Temperature 140 °C.** According to a chart published by the diaphragm's manufacturer, the burst pressure at 140 °C is equal to 90% of the nominal pressure given for 20 °C.

- **Manufacturing tolerance +/- 10%:** this tolerance generally varies between 3 and 10% depending on the nature and the price of the diaphragm.
- **Fatigue coefficient 85% of the minimum bursting pressure.** On a batch process, a diaphragm is subjected to repetitive stresses that weaken it. The fatigue coefficient or service rate enables this phenomenon to be taken into account. It can vary from 70 to nearly 100% depending on the type of diaphragm.

Thus on the incriminated diaphragm, the **nominal burst pressure of 3 bar at 20 °C** is no more than 2.7 bar at 140 °C with a tolerance of +/- 10%. In the unfavourable case, the burst pressure of the new diaphragm is thus 2.43 bar. After being commissioned, however, and subject to fatigue, **the diaphragm may rupture beyond a pressure in the reactor equal to 2.07 bar.**

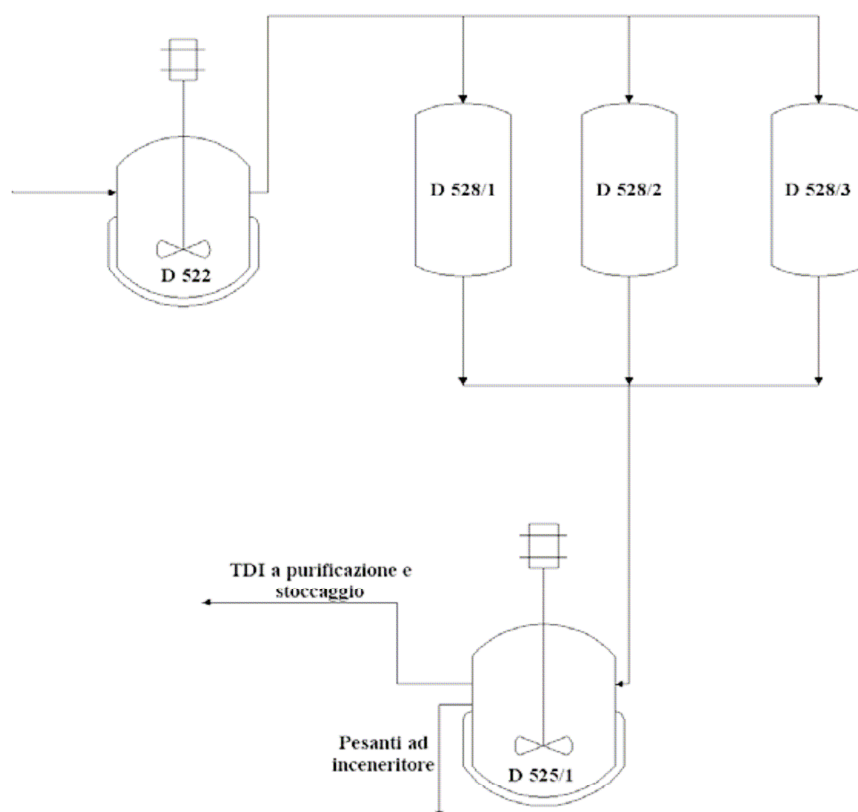
Fig. 1 - Simplified scheme of TDI section

The TDI /high-boiling tars mixture in report 1:1 from the bottom of the evaporator is sent to tank D522 to cool it to 90°C, which is equipped with a stirrer and water refrigerated coils manually regulated. The mixture is then sent to the tanks D 528/1-2-3 for storage, which feed the section of high-boiling tars treatment, where in a vacuum batch process is carried out a discontinuous recovery of a part of TDI from the same mixture (a simplified scheme of TDI section is shown in fig. 1).

The TDI is recovered by evaporation in the concentrator D 525/1, equipped with a stirrer, steam heated coils and maintained at vacuum pressure. It works at 10 mm Hg of residue P, and 130-150°C of T. Concentrator D 525/1 is fed by the tanks D 528/1-2-3 working also as compensation tanks. The TDI vapours are then condensed and then the liquid is transferred for storage, the residual gas is sent through a separator and then suctioned by the 3stage vacuum units P 509/1-3.

The concentrate present in D 525/1 is composed of 18-20% TDI and for the remaining part of high-boiling tars is diluted with toluene, mixed and transferred over a pump in tank D 541, where it is continuously stirred at a temperature of 115 - 120°C to get a sufficiently fluid and stable mass to be sent into the incinerator B 502/2 for combustion.

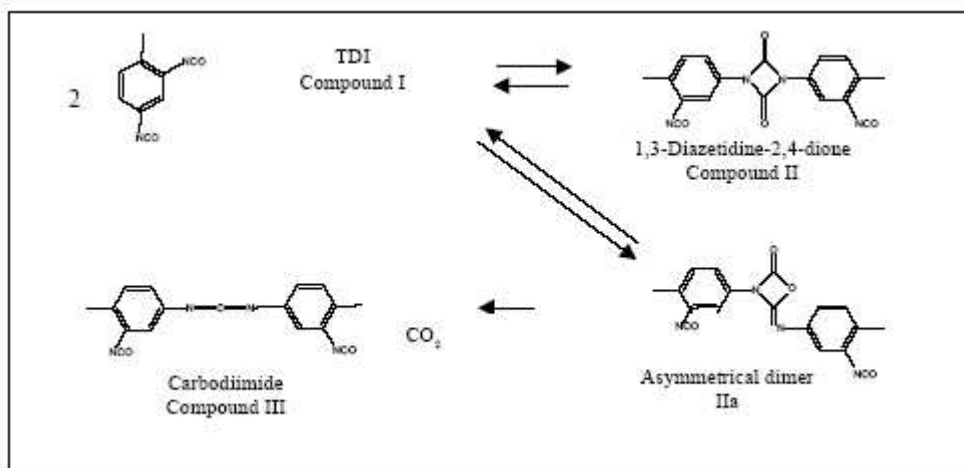
Fig. 5 - TDI dimerization with developing of carbon dioxide

The test results agree basically with the values registered by the DCS during the accident, and demonstrated the development of two distinct reactions, one exothermic reaction (fig. 6 and 7) and another one developing carbon dioxide (fig. 5).

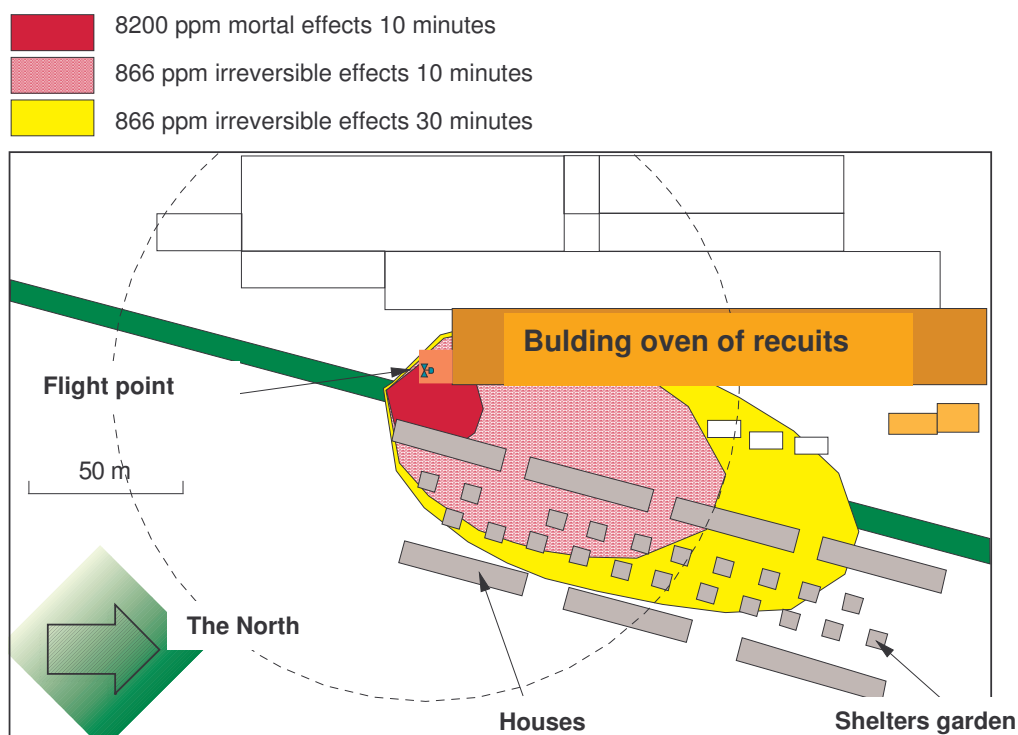
Fig. 4. Probable path of the toxic cloud

Based on 15 kg per minute for 10 minutes, the toxic cloud is estimated to have travelled approximately 120 m for the limit of irreversible effects.

After the cloud had passed, the concentration inside a closed but unsealed dwelling of the first building may have become dangerous if it had not been evacuated.

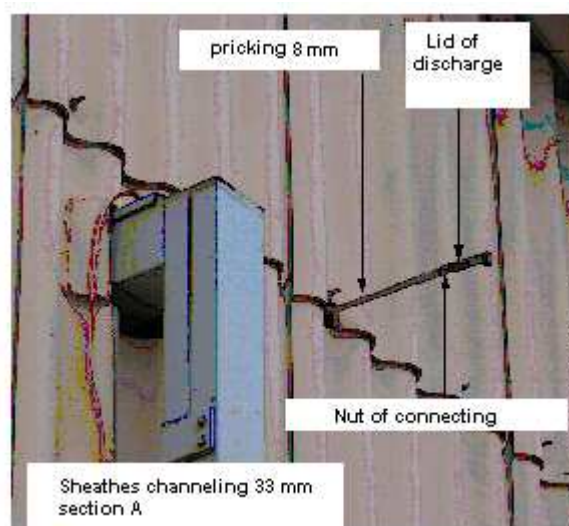
Fig. 7. Valve outlet on building facade

The fitting had been installed by a sub-contractor who frequently intervenes at the site.

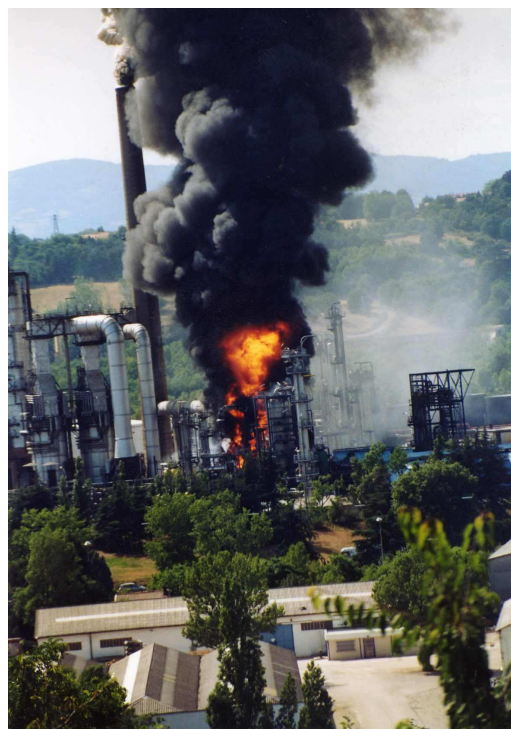
Personnel working at a neighbouring site were able to rapidly sound the alarm and manually opened part of the water curtains before the fire brigade arrived to the site. The operator stopped supplying the unit (load and hydrogen) and began decompressing via the flare stack, which rapidly reduced the combustion. The furnace's load-bearing structures, subjected to an intense thermal flux, were cooled down.

The ignition of the products coming from the reaction loop (reactor 42R202) continued intensely for a few hours in the furnace's convection chambers and flue exits.

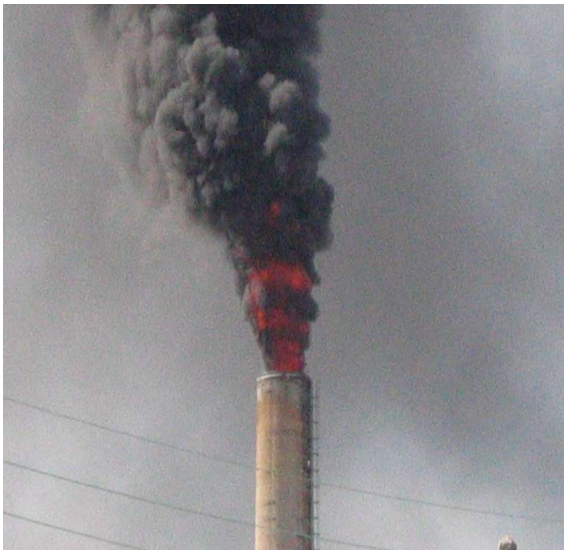
Intermittent flames were observed for several minutes at the outlet of the common stack that collects the atmospheric releases from the HDS units, atmospheric distillation No. 2 (DA2) and removal of aromatics (hydrotreating section No. 2 - HDT2) and a significant plume of smoke.

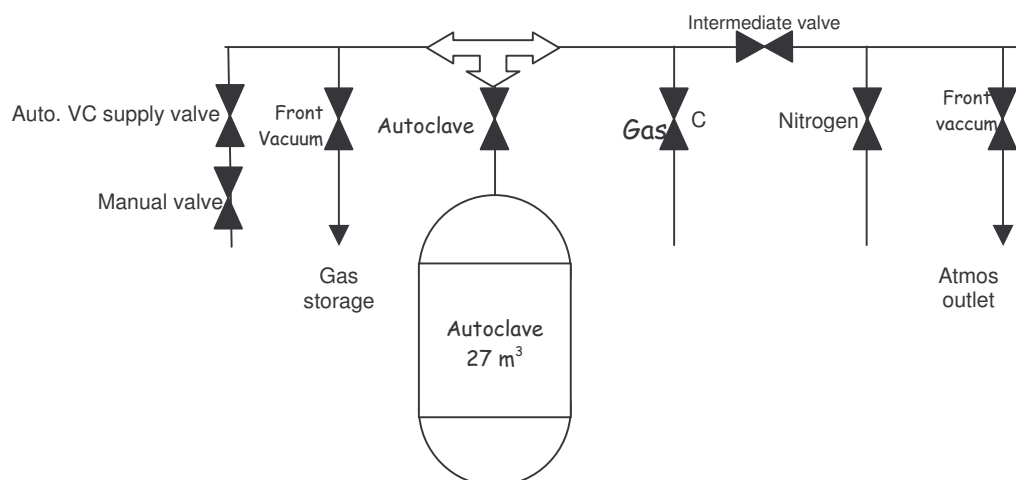
The diagram below shows the set of shut-off valves and their position at this moment:

**Causes identified:**

- Cause No. 1: poorly qualified preliminary manoeuvres prior to VCM supply authorisation,
- Cause No. 2: permanent monitoring fault of the "Front Vacuum" network.

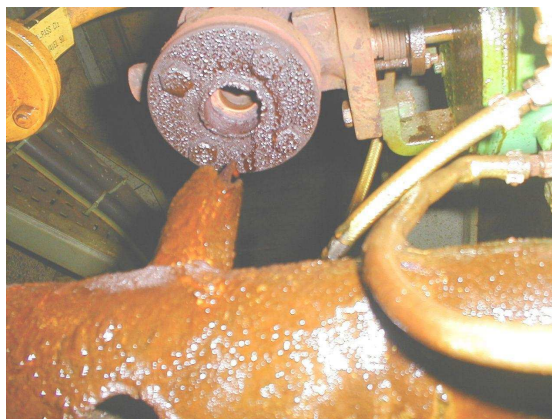
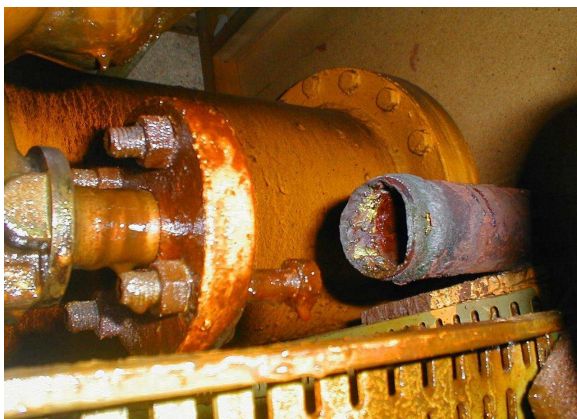
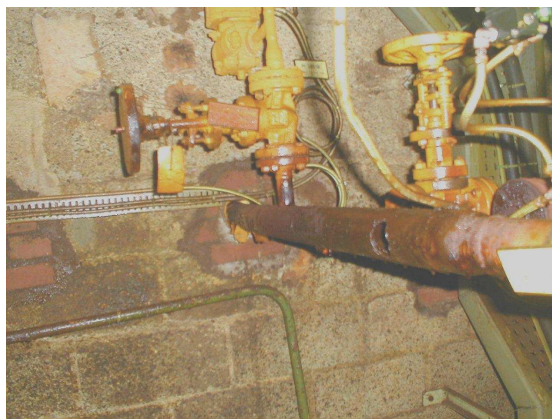
The expert assessment conducted immediately following the incident showed that the leak, located along the limit of the confined zone, resulted from the combustion of the steel in the chlorine on a pipe transporting the gaseous chlorine: at two locations (located near zones in which the pipe size was reduced: valve and venturi), the pipe had disappeared over several centimetres, including a flange. A hole of diameter equal to that of the pipe (8 cm) was created in a third location.

The combustion of steel in chlorine is a process that is initiated when the steel is brought to a temperature above 130 °C. Once this reaction begins, it is self-sustaining until all the chlorine has been consumed.

The operator identified the cause of the iron/chlorine combustion process as a hydrogen-chlorine fire whose ignition energy is sufficiently low to start spontaneously due to an output restriction or a significant flow rate. The increase in the output to 1,000 kg/h could have also supplied the ignition energy required.

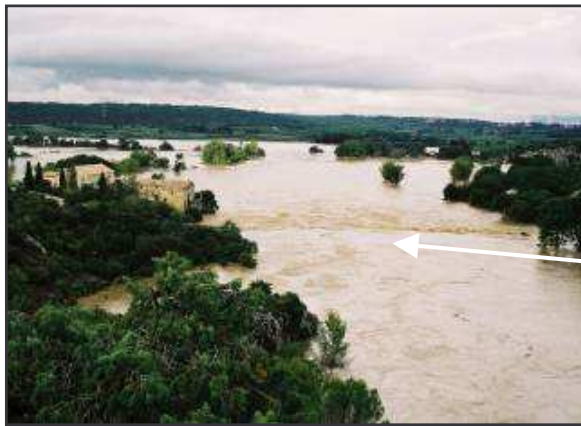
The Saint-Nicolas bridge in Uzès (Gard), submerged by flood waters - 09/09/2002

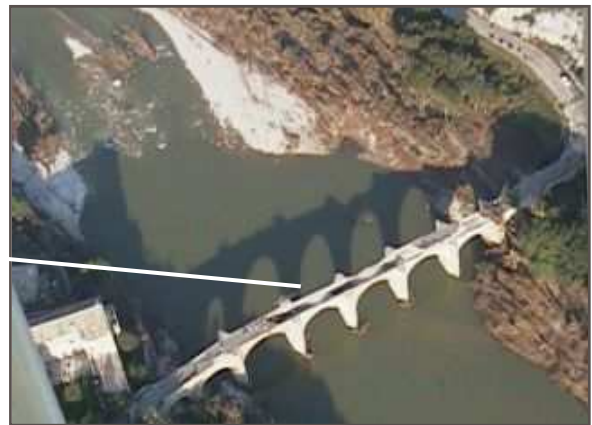
View of the bridge 5 days later

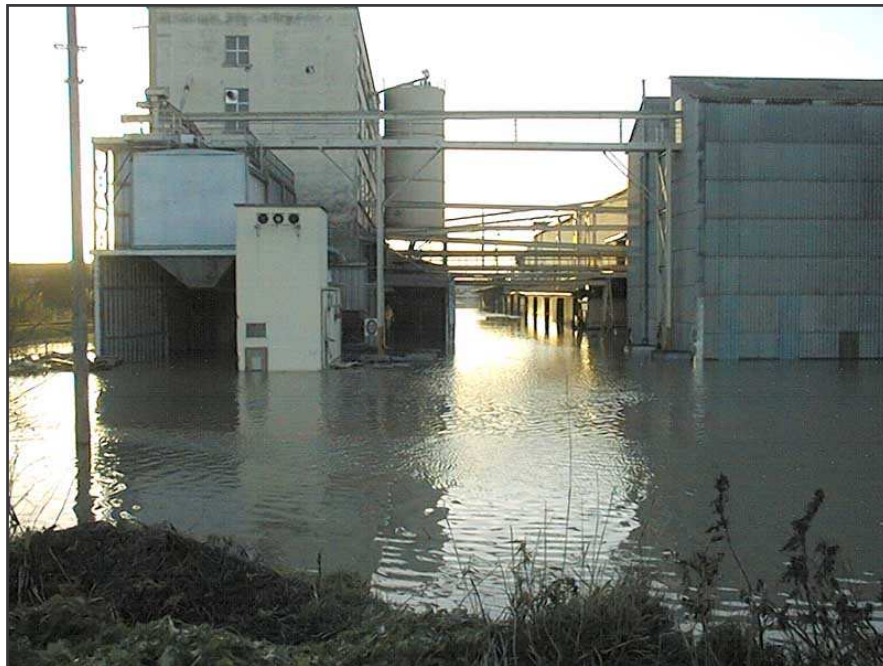
Flooding of Arles - December 2003

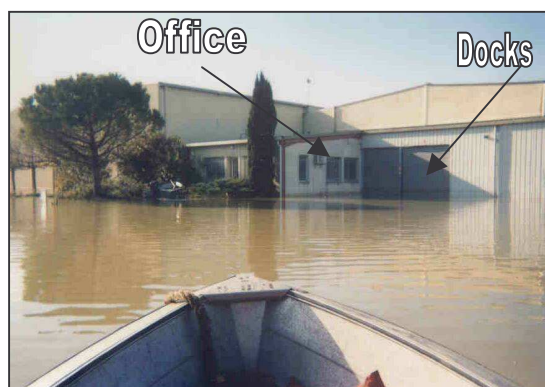
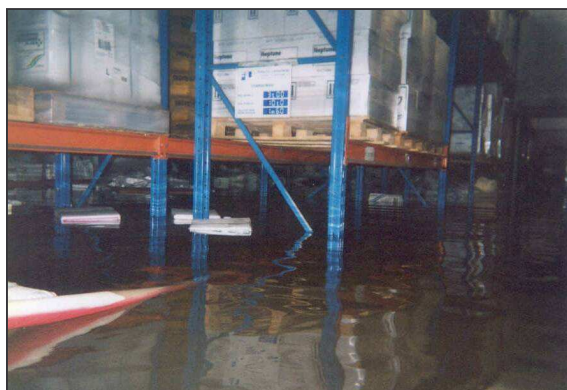
Little by little the water rose above the loading docks and reached the storage units; 0.9 m at mid-day and 1.43 m the next day. Surveillance rounds of the facilities were conducted and the water level monitored for 14 days following the flood.

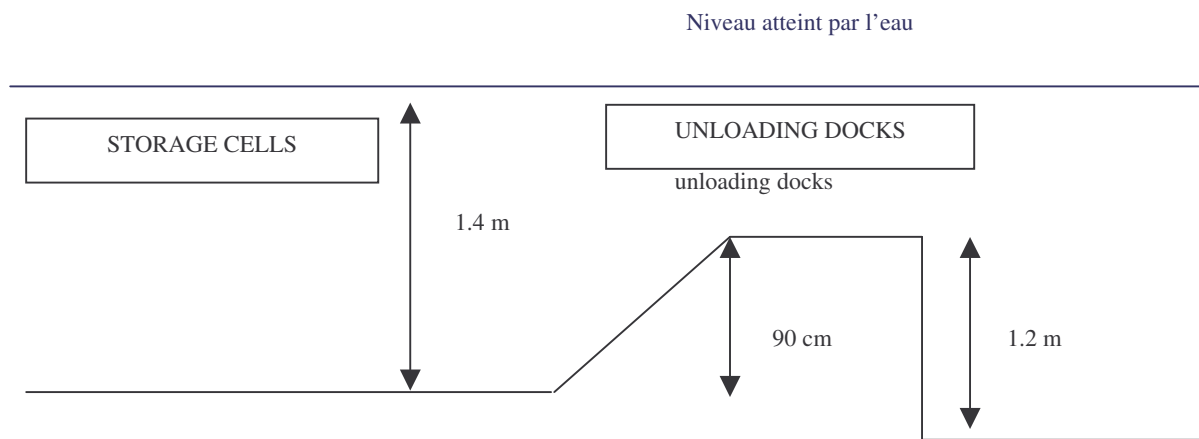
Diagram of water heights on the docks and storage cells

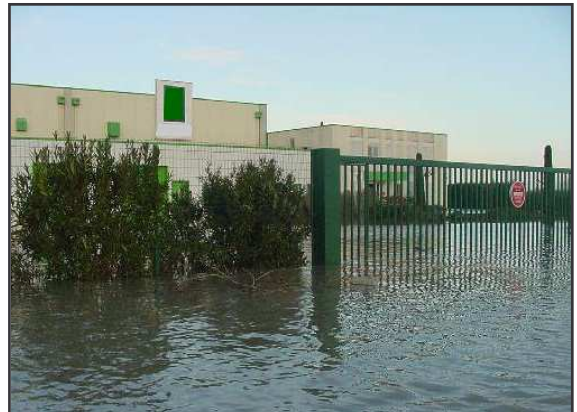
Several days later, the Classified Installations Inspectorate noted that the water had risen 90 cm in the storage units and 57 cm to the level of the loading dock and offices.

- raised the electrical installations above the flood water level,
- modified the management of stocks in order to raise humidity-sensitive products,
- rework the sealing of the 3 storage units (with the application of resins), even though the floor was not damaged.

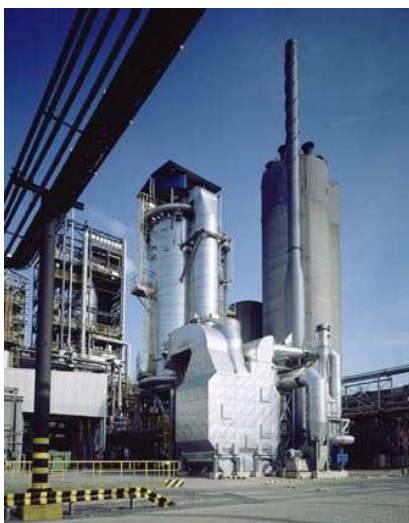
The oven before the accident

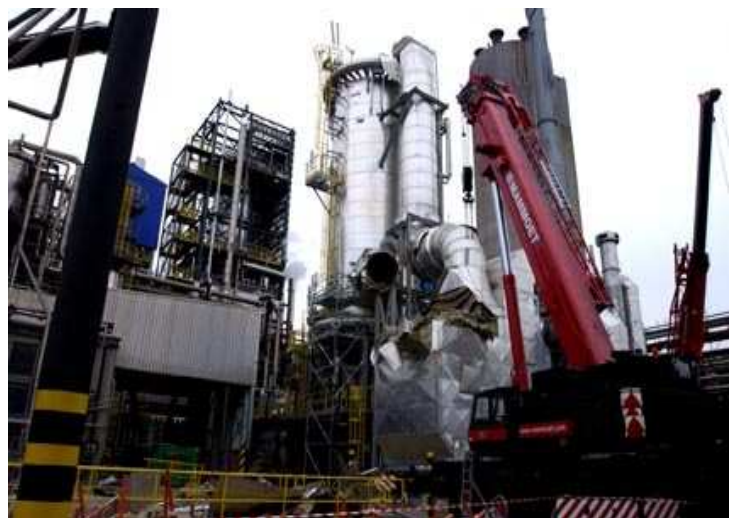
On restarting the oven filled with a combustible mixture of gas and air, which was *probably ignited by an errant spark from a ventilator started by an operator*.

The explosion caused the lid of the oven, on which a maintenance crew was working, to be blown off. The lid fell down in the oven, together with the crew who were standing on it.

The oven after the accident

The underlying cause consists in the use of the fast track procedure employed to restart the oven. This procedure was designed to by-pass safety measures prescribed in order to safeguard the safe restart of the oven. By doing so, explicit safety instructions were ignored.

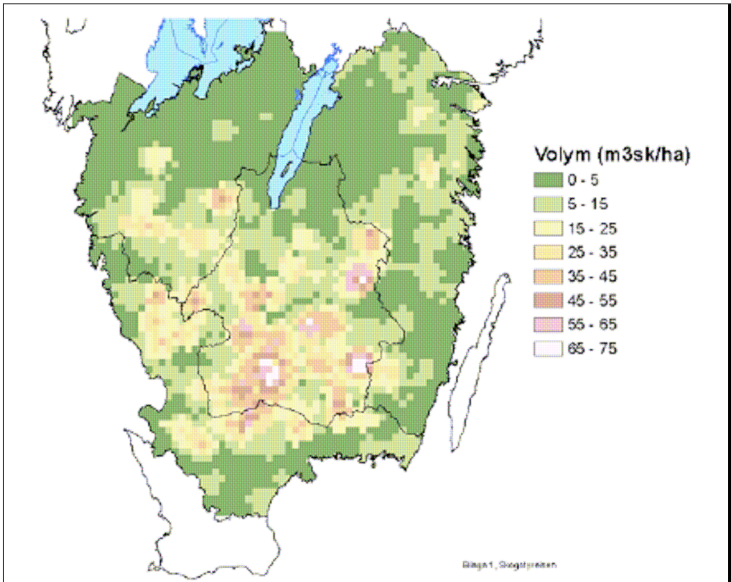
The storm mainly affected the southern parts of Sweden. In this area, the quantity of coniferous forests with spruce is large. The major effects caused by the storm consisted of fallen trees, shown in the map below illustrating the volume of timber damaged in different parts of southern Sweden (Figure 1).

Figure 1 – Volume of timber per hectare (10 000 m²) damaged by the storm in January 2005
