Lessons learnt from industrial accidents 2023 Seminar

23-24 May 2023

Date of report: 12/06/2023

Report number: 2022(II)

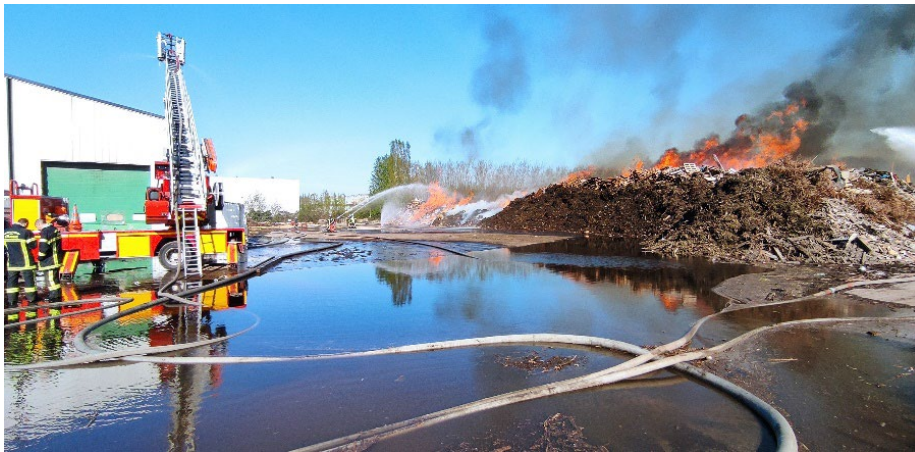
[ARIA 57253](#): Fire in a non-hazardous waste sorting, transit and consolidation centre

illustration photo

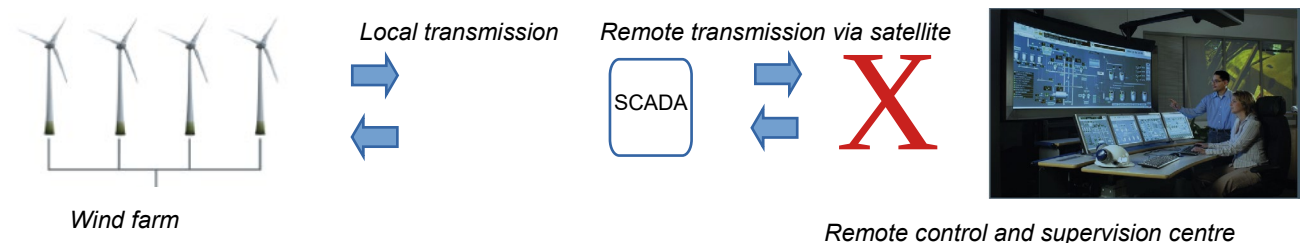
A cyberattack originating from a computer virus targeting a satellite resulted in the loss of communication between the remote control and supervision centre of the maintenance personnel and the supervisory control and data acquisition (SCADA) system of numerous wind farms. This attack might have been linked to the start of the war in Ukraine on the same day. Among the many activities using this satellite for communications, 30,000 wind turbines were affected in Europe, including about 50 wind farms in France.

The SCADA manages and processes a large amount of telemetry in real time. It controls technical facilities and alerts operators in the control room through alarms if the physical parameters of the industrial process are out of range. The wind turbines continued to generate electricity and operate in automatic safety mode.

For French wind farms, operators implemented the following mitigating measures:

- daily monitoring visits to farms;
- increased monitoring of weather conditions;
- for certain farms with local wired control, regular transmission of the information collected to the remote control centre of the maintenance personnel.
