# LESSONS LEARNT from INDUSTRIAL ACCIDENTS

# 10<sup>th</sup> SEMINAR

29 and 30 May 2013 – Strasbourg

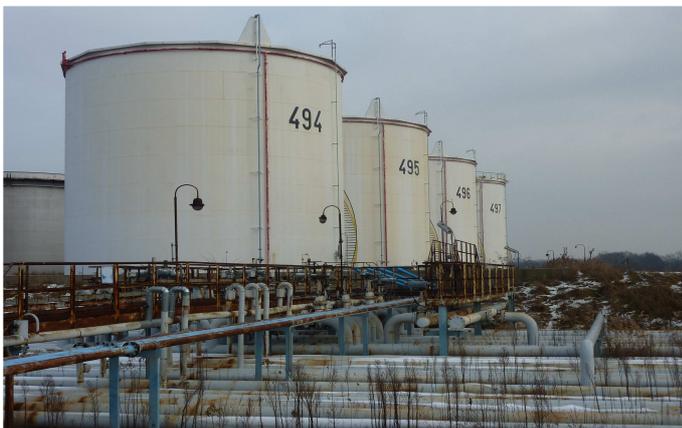
Figure 2: View of the storage tanks  
(source: DREAL Environmental Agency, Alsace)

Tank T 495 - 17 m in diameter and 18 m high - had been fitted with a floating roof, a radar-based operating level measurement installed in a vertical shaft, and a safety high-level measurement system (independent of the operating level and also performed in a vertical shaft, Fig. 2).

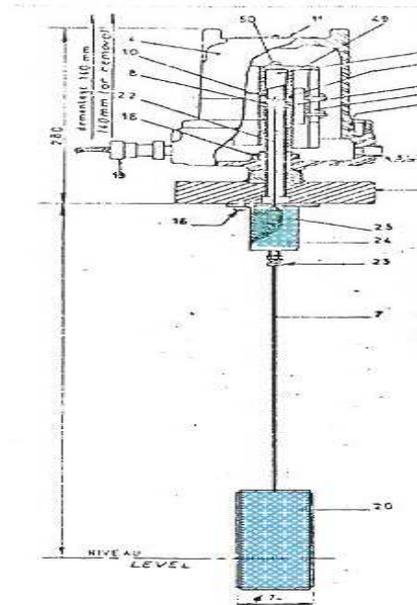
Figure 3: MIP operating diagram (source: Site operator)

The high-high level safety measurement relied upon a system called MIP (for Marine Instrument Petroleum) that operates according to a different principle than the radar-based level measurement (Fig. 3). This system comprised a plunger hooked up to a hose connector and a spring, plus a vertical shaft connected to both the spring and a mercury bulb switch. With this set-up, the switch activation triggered a high-high level signal visible in the control room, thus initiating immediate shutdown of the transfer operation.

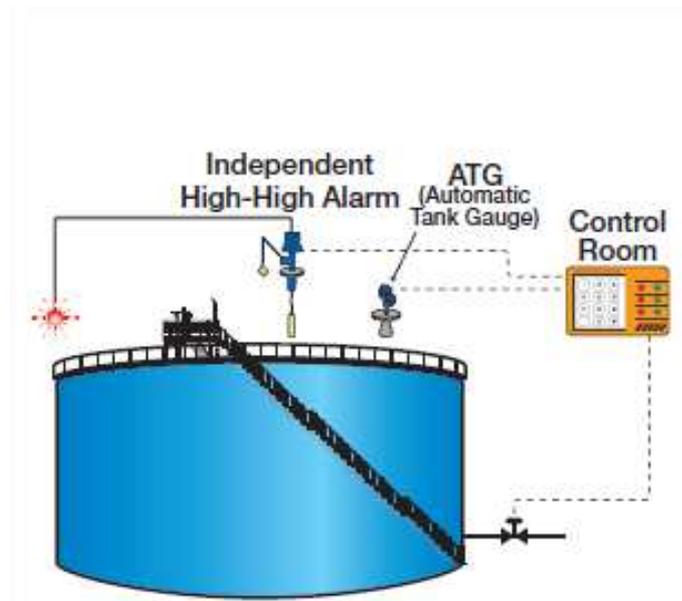
*Figure 7: The American API 2350 Standard classes as Category III any storage tanks managed remotely; moreover, it recommends use of a high-high level safety sensor that is independent of the operating level (ATG) sensor and, preferably, offers self-diagnostic capacities relative to its malfunctions and defects.*

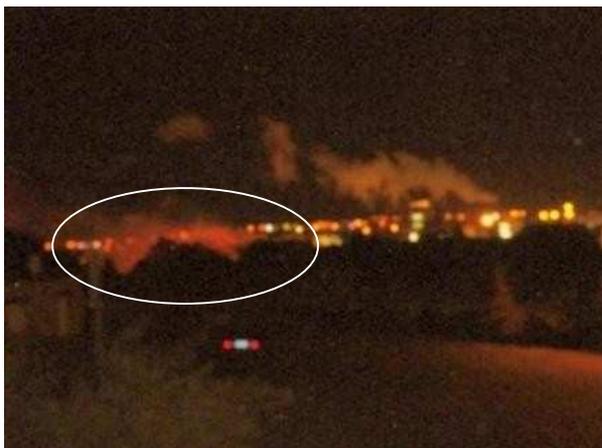
*Photograph of the cloud before its dispersion*

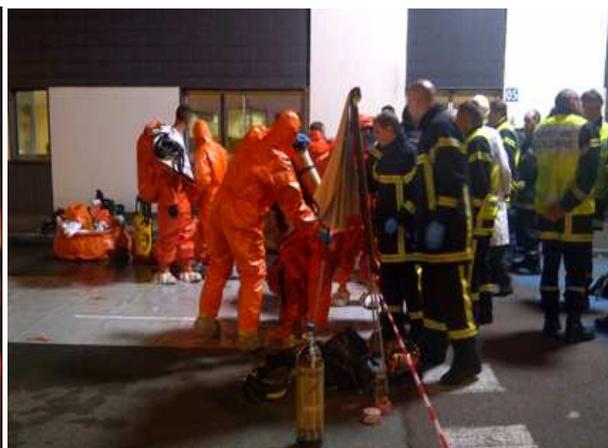
*Fire-fighter intervention wearing diving suits*

Though it appeared at the outset that these emissions were due to product decomposition, a precise diagnostic of the accident (targeted installations, plus their possible evolution) was not immediately forthcoming since building access had been obstructed by the substances being released. Responders had to wear diving suits to survey the premises, during which they determined that the emissions had originated from a burst glass tube connected to the DICOA dryer, which was still being heated and whose contents had begun decomposing.

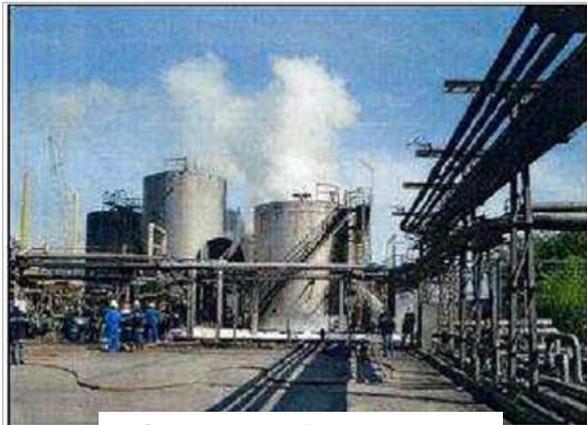
Storage zone - All rights reserved

The following photographs reveal the physical state of the installations after the accident.

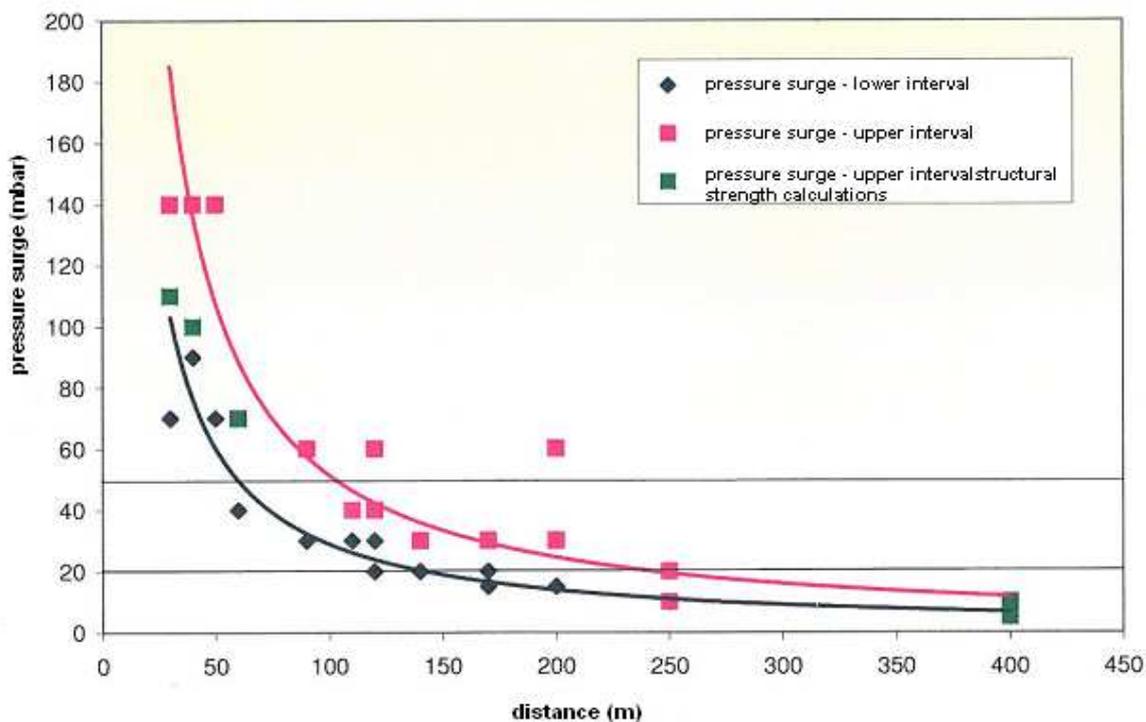
Subsequent to this accident, the INERIS Institute estimated the effects of pressure and the distance over which the pressure surge had caused damage (see detailed accident data sheet downloadable from the site: [www.aria.developpement-durable.gouv.fr](http://www.aria.developpement-durable.gouv.fr)). Pressure effects could be observed as far as 400 m away (a few shattered windows).

During their survey, appraisers also noted that the effects of pressure were more widespread than thermal effects (within a 50-m radius), which in general appeared as broken windows, cracks in building walls and the destruction of cladding.

Estimation of the effects of overpressure by INERIS from damage during the Dagneux accident.

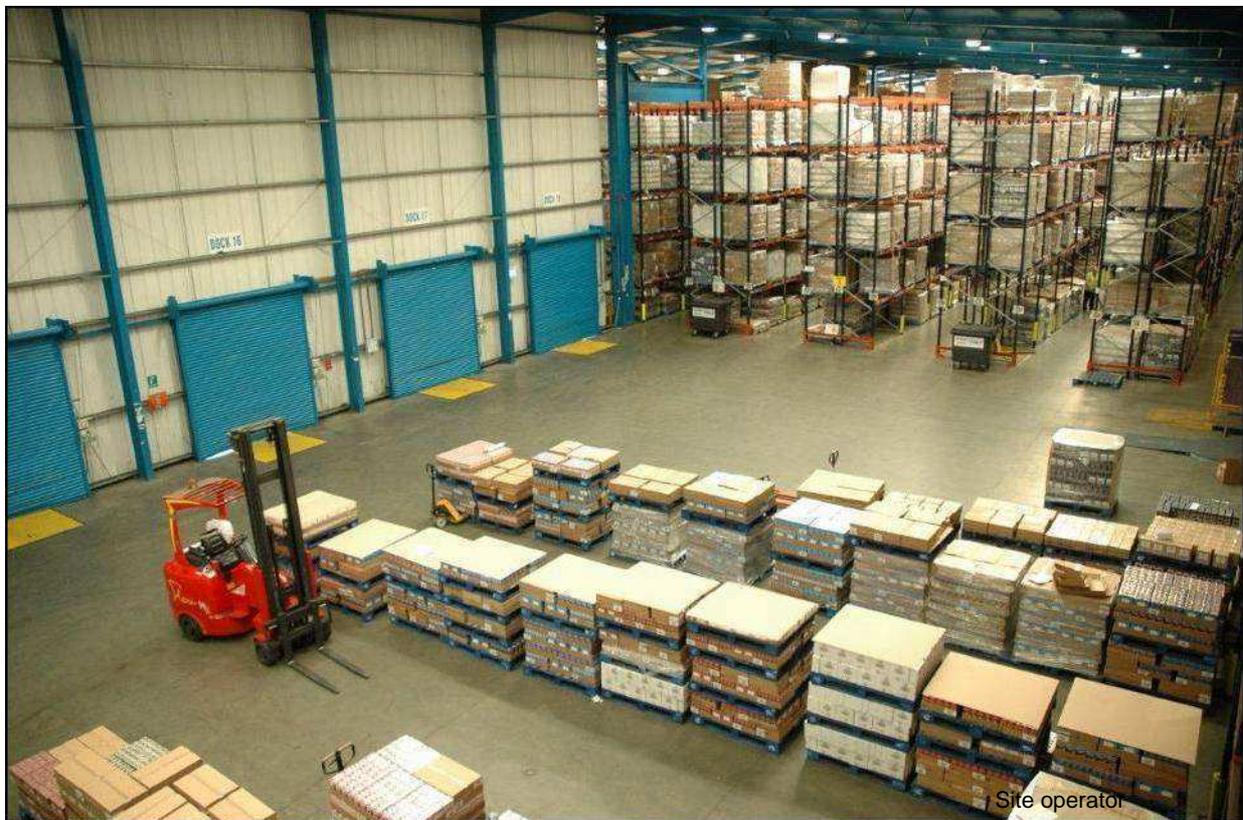
Figure 1: Interior of the facility prior to the accident

The warehouse where the accident occurred contained approximately 4,000 pallets of aerosols with a typical composition LPG/Ethanol 60/40 %w/w. The warehouse also contained a similar number of pallets of liquid (aqueous) hair colourings and shampoos in plastic bottles. Palletised products were stored on racks up to 6 levels high. Pallet handling involved 7.5 tonne electric flexi-trucks. Aerosol storage areas are not normally zoned under the ATEX Workplace Directive and the trucks at this site were not rated for use in a potentially flammable atmosphere. The warehouse was not sprinklered.

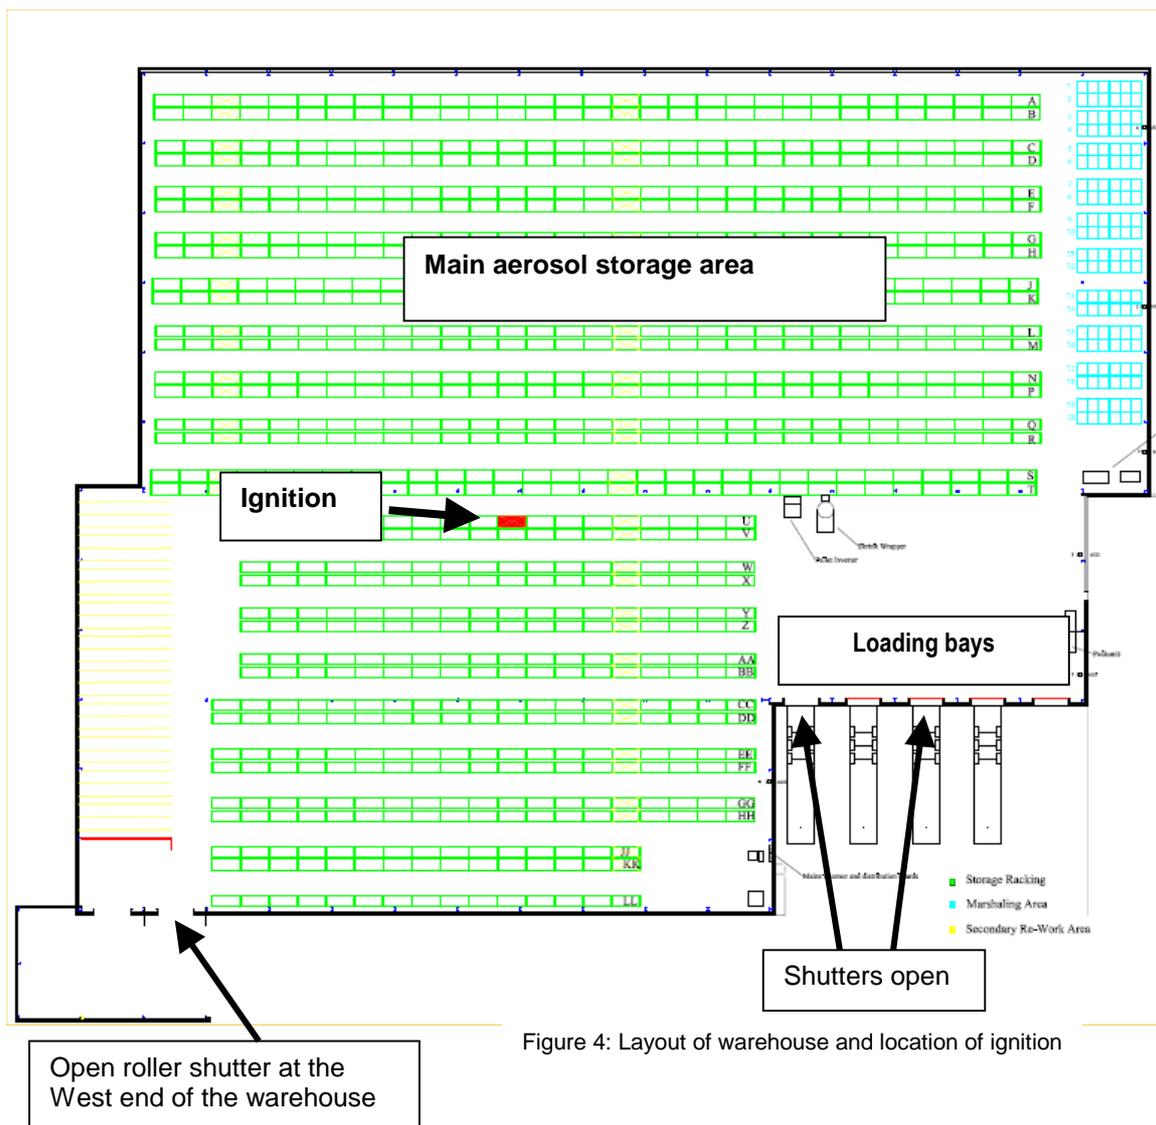
Figure 4: Layout of warehouse and location of ignition

The ignition of plastic and cardboard observed by the witnesses tends to suggest that there was a liquid spill within the pallet. There is not enough information available from witnesses or from examination of the fire scene to be able to distinguish between these variations on the themes of leaking aerosols, truck impact and spark ignition.

When first spotted by the lift truck driver the flames were only 300mm high – towards the base of an aerosol pallet at ground level. A small foam extinguisher was used and initially the visible flame was knocked down but seconds later flames broke out again. Witnesses fighting the fire then heard a popping noise that they recognised as the failure of an aerosol can and started to run out of the building. The last worker to leave reported his final impressions of the fire: “..the fire had started to spread to adjacent pallets on either side of it and above. It was spreading surprisingly quick and was beginning to spread towards pallets opposite. You could hear popping and rumbling. This all happened over seconds. There was thick dense black smoke which was spreading up and along the ceiling.”

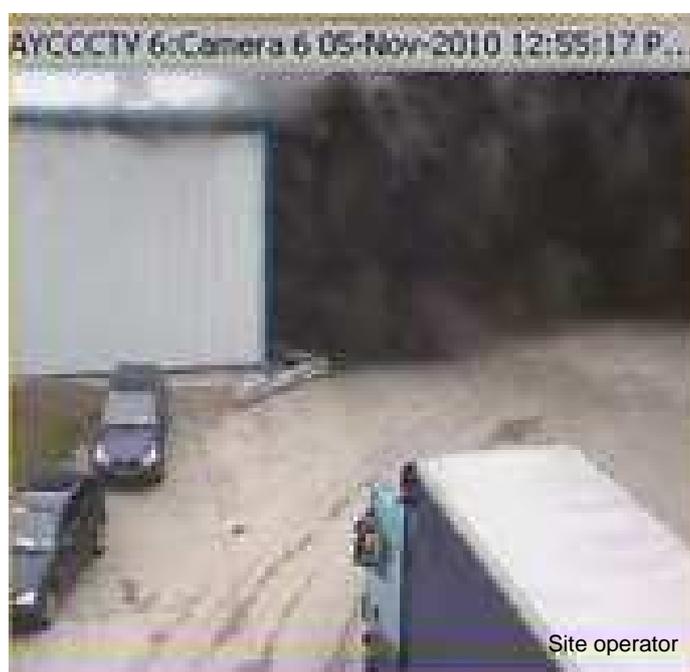
- ii. Fire growth in aerosol stores can be extremely high. Even in large buildings the time available for escape can be as low as 100 seconds. This means that emergency planning is of prime importance. Fire evacuation should be practised regularly with 100 seconds being the target evacuation time.

Figure 5: Smoke flow from the building 135 seconds after the fire alarm was sounded

- iii. Careful attention should be given to mezzanine levels (that are rapidly affected by smoke) and any separate compartments from which escape is only possible through the warehouse. Special risk assessments may be needed where people are working at elevation and cannot get down quickly (e.g. scissor lifts). For example, it may be necessary to suspend the use of unprotected lift trucks within high rack storage areas (where they can start ultra-rapid fires) if there are people working in locations where they cannot escape quickly in response to an alarm.

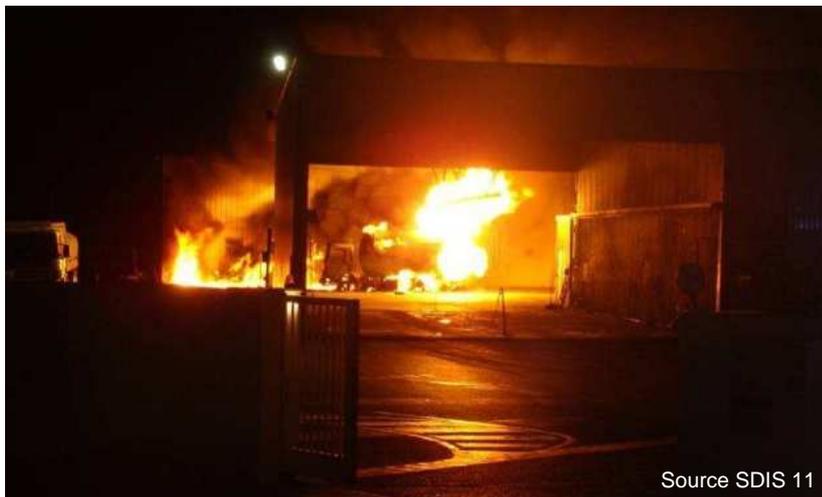
Photograph of a fire-fighter arriving at the scene of the accident

In attempting to cool the cistern while remaining 100 m away, due to the inherent BLEVE risk, responders heard a whistling noise at 12:16 am and retreated to safety just before the BLEVE explosion of the tanker lorry and the ensuing "fireball" observed by eyewitnesses.

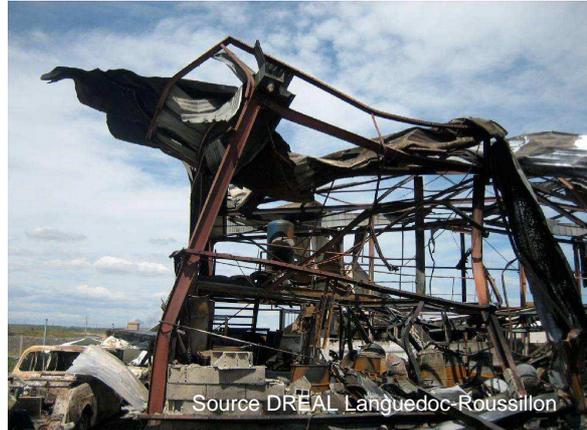
The tanker lorry exposed to this BLEVE was destroyed by both the explosion and fire. The only part remaining on the ground was its engine, as the cistern was found "flattened" on the roof of the repair shop's metal building structure.

"Flattened" cistern thrown onto a roof

- the largest fragment, comprising most of the shell of the "flattened" cistern, was thrown onto the roof of the repair shop's metal building;
- two pieces were identified outside the site at 20 m and 70 m in front of the lorry, along its alignment;
- a bottom piece (steel flange) was projected in the opposite direction from the previous fragments, beyond the site boundary 150 m from the ignited vehicle.

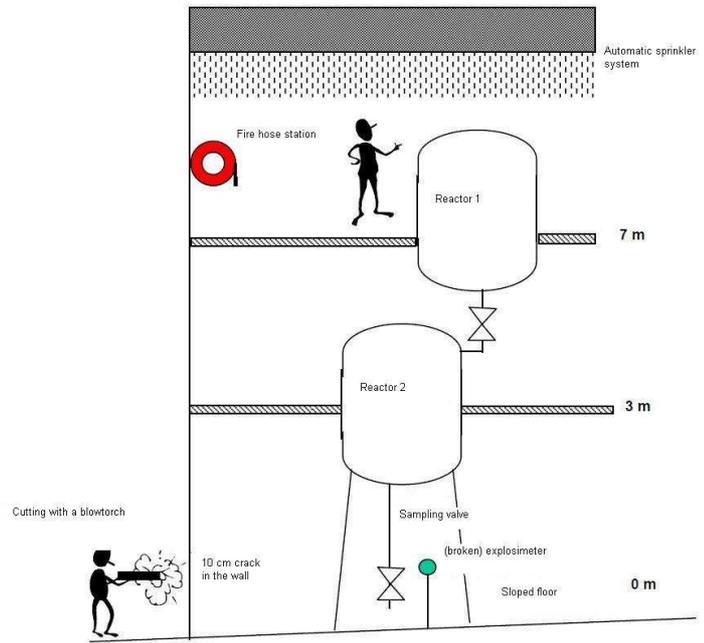
In a workshop manufacturing active pharmaceutical ingredients, at around 3:30 pm, a technician initiating a cleaning task transferred acetone from one reactor (level: 7 m) to another (level: 3 m), whose **low-point sampling valve had been left open** (level: 0 m). The solvent spilled out along the slope of the workshop floor towards a wall containing an unobstructed 10-cm wide opening, on the other side of which a subcontractor was cutting metal with a blowtorch.

A 2<sup>nd</sup> technician noticed the leak and closed the valve. **An explosimeter, inoperable for 3 days** (due to a connection problem), had still not been repaired. The acetone fumes ignited outside the workshop, then the fire instantaneously spread underneath the reactor and to the upper floors via a hopper. A safety technician activated the internal emergency plan siren, effectively locking down the workshop; electricity supply was shut off and the wastewater drainage network diverted to a retention basin. An onsite agent deployed a fire hose station from the 7-m level; the deluge sprinkler system was tripped a few minutes later and extinguished the fire. The water was left to cool installations for another 20 min. Employees wearing self-breathing apparatuses surveyed the workshop, and the emergency plan was lifted 30 min after its initial activation. **The site operator analysed this accident, which had occurred when conducting summer renovations, reconfigured the workshop floor drainage slopes and modified all working procedures involving hot work permitting:** memorandum circulated among workshop technicians; establishment of a defined works schedule; ban on open flames in all designated high-risk zones during operation phases; installation of dedicated electrical outlets for subcontractors, which were hooked up to the explosimeter detection system and solely supplied during the time period assigned to hot work permit tasks.

Diagram of the accident situation

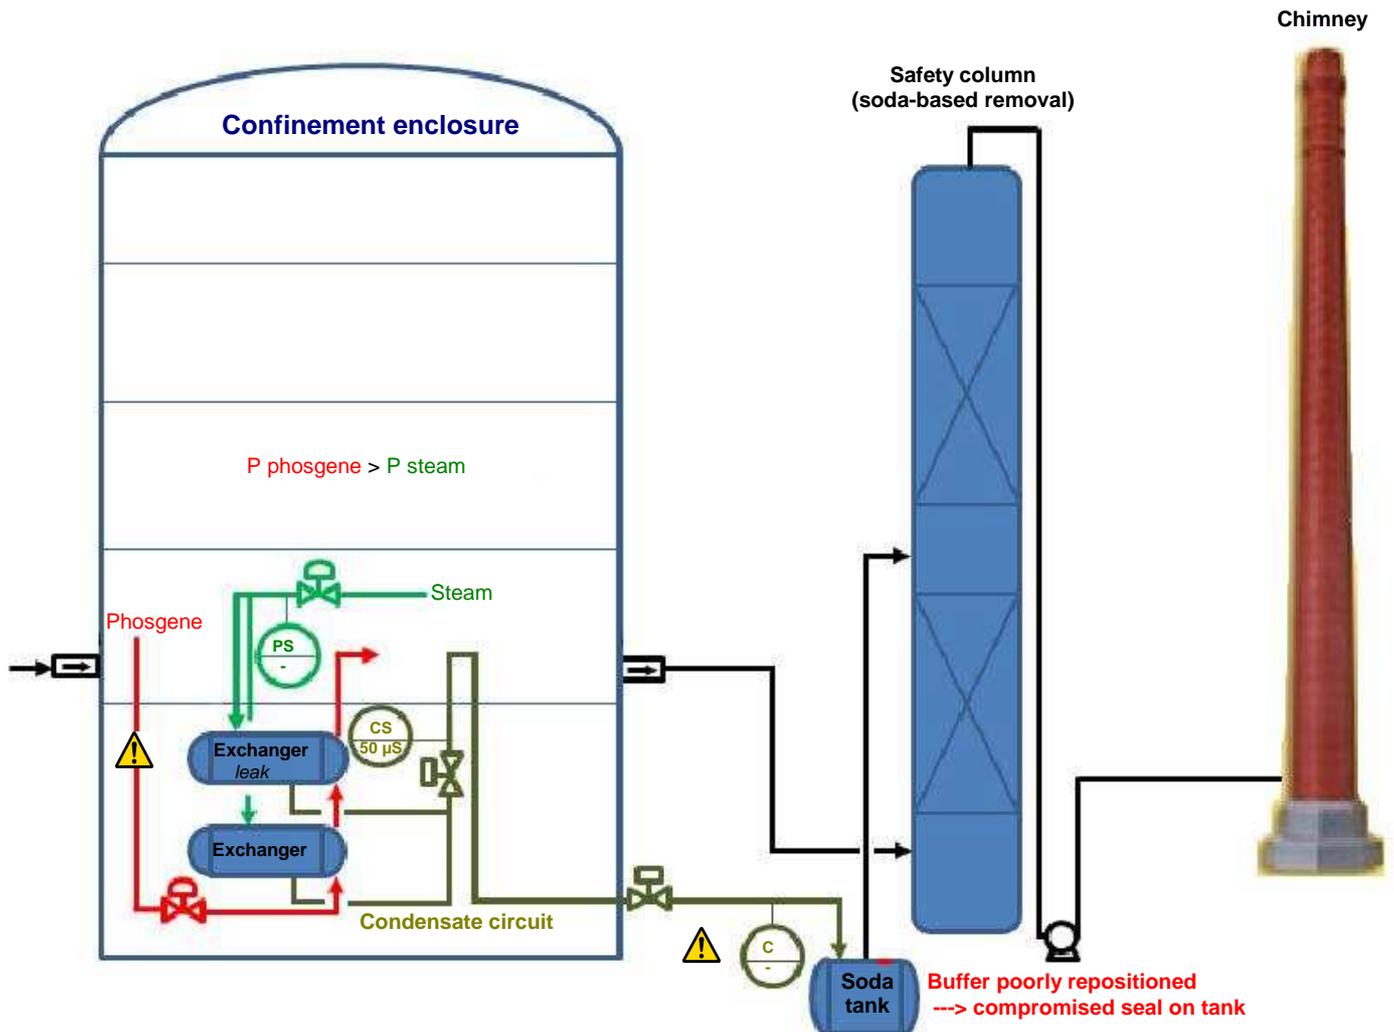
**Simplified diagram of a portion of the HDI (isocyanate) workshop process**  
*(State of the installation on the day of the accident)*

Sensor measuring condensate conductivity with a safety action programmed at 50 µS → isolation of the condensate circuit and shutdown of the phosgene pump

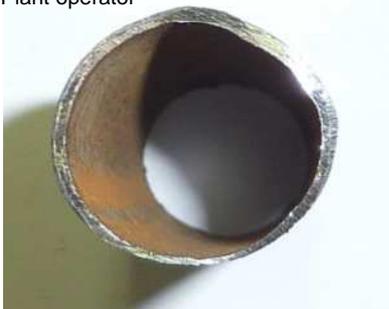
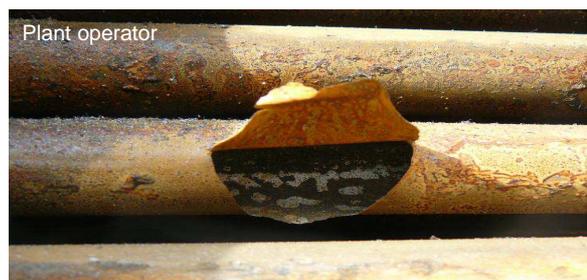
Plant operator

The phosgene release in the direction of the exchanger's tubular shell subsequently induced external corrosion on the tube that eventually leaked and, to a lesser extent, on adjacent tubes. For the originating tube, the level of corrosion was such that the residual steel thickness was no longer adequate to resist the differential pressure, which in turn caused the tube to burst and a major release of phosgene within the shell.

Phosgene release into the atmosphere resulted from poor repositioning of the soda tank buffer following its most recent drainage; its seal however would have allowed eliminating phosgene via the safety column.

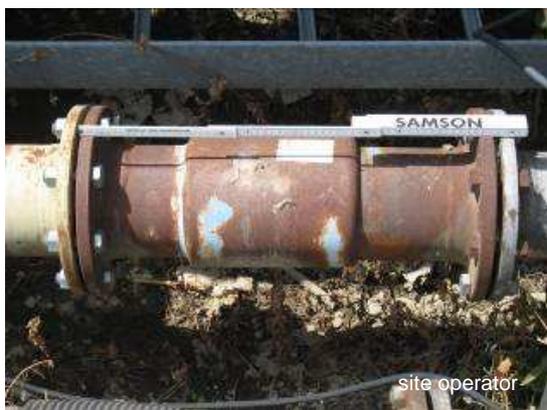
Expansion compensator before the accident

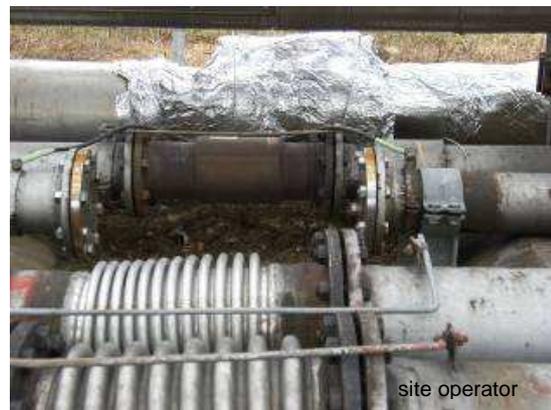
The pipe's expansion compensator burst due to the pump's repeated malfunctions and restarting under high pressure. Post-accident investigations revealed that a water hammer phenomenon occurred and was then accentuated by the following technical aspects:

- The 450 m long pipe could not be positioned along a constant incline due to both geographic constraints and the site layout.
- Repeated pump malfunctions led to its cavitation, triggering the formation of cavitation bubbles.
- Pump start-up under more strenuous operating conditions led to a pressure surge that exceeded the pipe design pressure (16 bar).
- The narrowing cross-section (a nominal diameter drop of 150 to 80), combined with improperly placed support systems and the expansion compensator design, was responsible for leading to the breaking point.

Expansion compensator taken apart after the accident

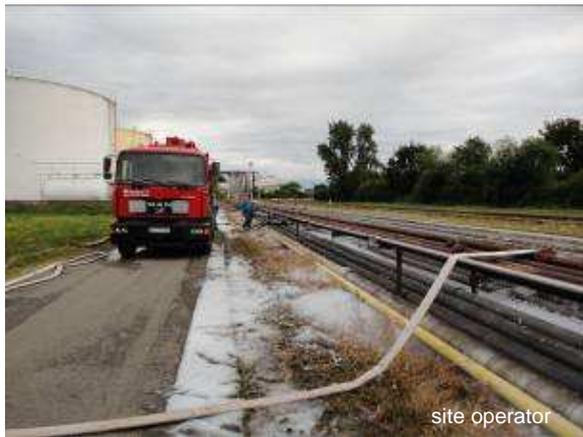
The hydrocarbon spill was immediately covered with a foam blanket. This task was further complicated by the difficulty of sorting spilled hydrocarbons from extinction water that remained after a fire drill held shortly before that time by local fire-fighters. The gas measurements recorded outside the site boundary indicated that the lower flammability limit had not been exceeded. The next morning, a specialised subcontractor proceeded to pumping of the foam blanket and hydrocarbon puddle. The bulk of the product (some 100 m<sup>3</sup>) however had penetrated into the unsealed ground (sandy soil). A long-term procedure, approved by the appropriate authorities, was launched: soil decontamination, well drilling and pumping out hydrocarbons (insoluble in water) from groundwater aquifers. This process is still currently underway.

Place of the accident the day after

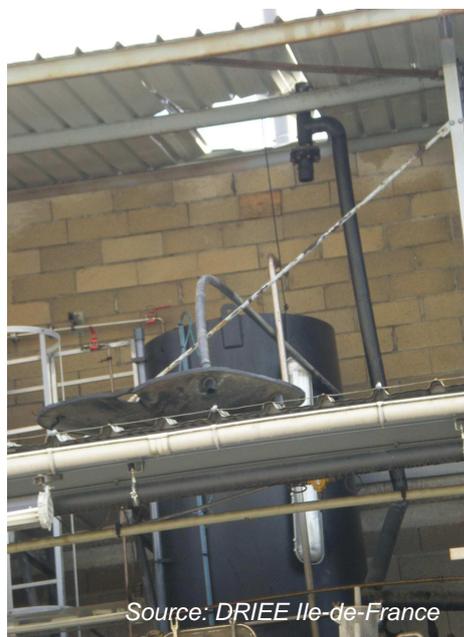
In an upper-tier Seveso-rated organic chemical plant, a subcontracted employee had been involved in welding work on a pipe running 2m aboveground for 30 minutes while perched on a stepladder. This repair job, requiring a gas tungsten arc welding (GTAW) station, was intended to connect a pipe used to inert a temporary solvent storage tank to the plant's nitrogen supply line. **This weld was undertaken following a quick nitrogen flush performed by the employee.** At 4:45 pm, just a few seconds after completing the operation, as the welder was climbing down from the stepladder and exiting the zone, the 10-m<sup>3</sup> polypropylene tank burst, sending its plug through the roof of the hangar housing the storage tanks. The worker and two other subcontractors in the zone were not injured. The classified facilities inspectorate was duly notified. A level sensor installed on the tank plug was ejected onto the roof and fell to the ground; the manhole, filling tap and pressure relief valve were also found on the hangar roof.

The damaged tank had been drained 3 months prior and degassed. **All of the damaged pipe had previously been verified by running water through it.** No combustion traces, combined with the fact that the damaged tank had been the only one capable of receiving nitrogen on the day of the accident (i.e. its shut-off valve had remained open), led to the hypothesis of a pneumatic explosion inside the tank. Despite being set at 30 mbar (strength threshold of the tank), the nitrogen expansion valve was capable of supplying a maximum pressure of 37 mbar and moreover, its good working order had not been assured. In contrast, the tank's pressure switch found on the floor indicated a pressure of 27 mbar. The accident might also have been caused by the rapid dilatation of nitrogen subsequent to its reheating when passing through the pipe segment nearest the weld (the GTAW weld had reached 1,000°C), though the level of the tank's liquid seal had not varied (it should have risen and overflowed in the event of a pressure increase).

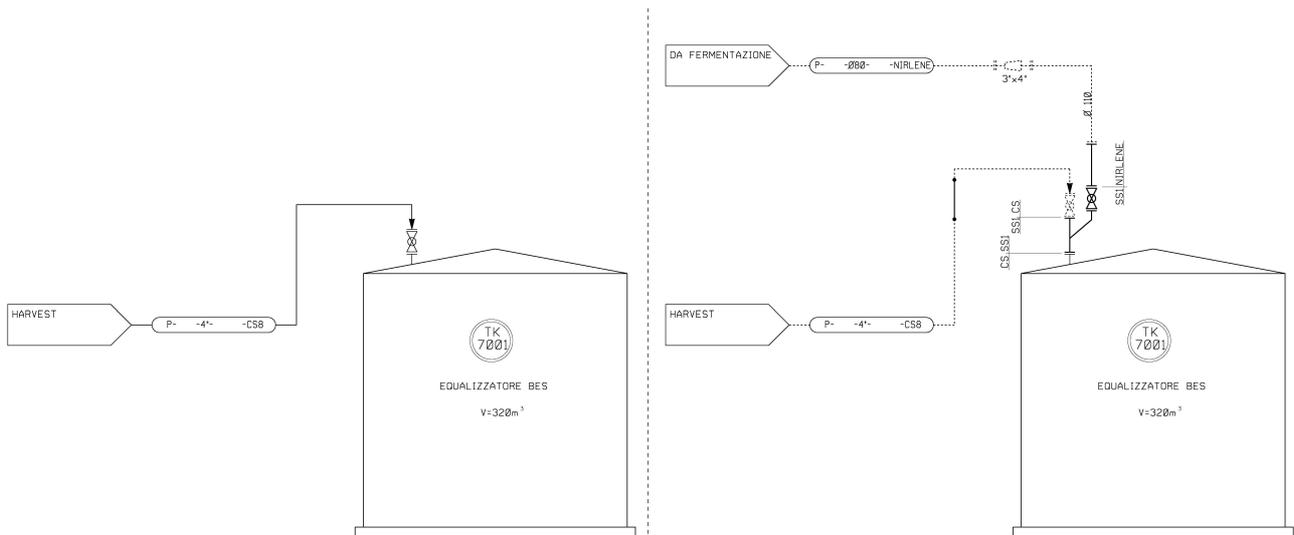
The aim of the operation was to add a second feed line to the TKX (Figure 4). Coming from the fermentation unit, it should have allowed the delivery into the TKX of the waste broth from a new antibiotic production unit. The existing feed line had been cleared up and disconnected from the tank, without closing (blind flange) the tank or the line. The tank was half filled with BES.

Fig. 4: (Left) Existing TKX; (Right) modification project at right (source: operator)

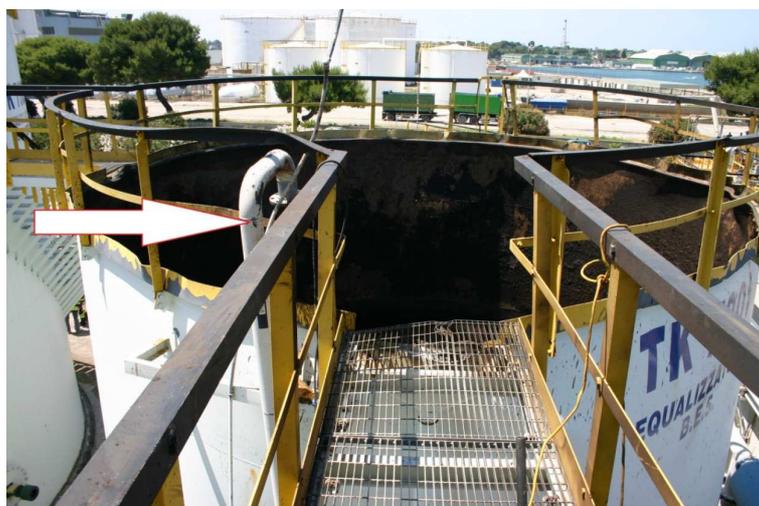
When the explosion occurred, the roof was torn out along the circular welding line (Figures 5 to 7) and thrown at a distance of 20 m, pulling up the air sparger line (Figures 8 and 9). The contractor on the roof was thrown on the roof of the TKY and died.

Fig. 5: Pulled-off sparger line on the TKX viewed from the walkway (source: ARPA Puglia)

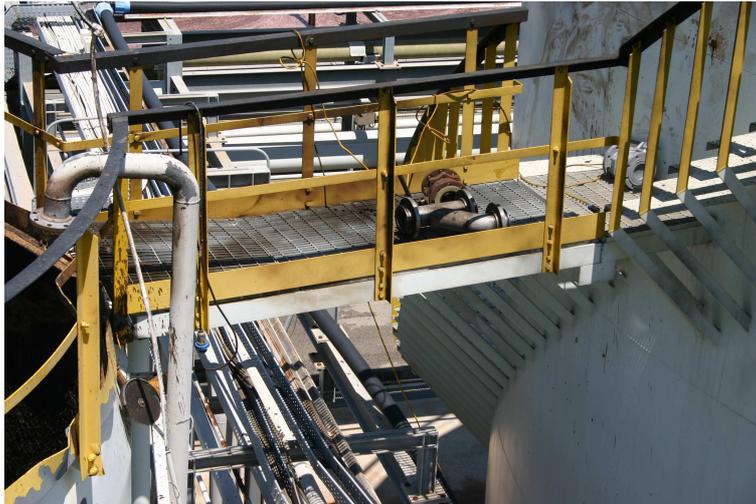
Fig. 6: Walkway between TKX and TKY (source: ARPA Puglia)

- A.** An explosive atmosphere was present inside the TKX, which was ignited by the sparks generated while cutting the feed pipeline by the electrical cutter. The feed line had been cleaned up and disconnected from the tank without closing them with blind flanges, and leaving the nozzle on the tank opened (Figures 6 and 9).

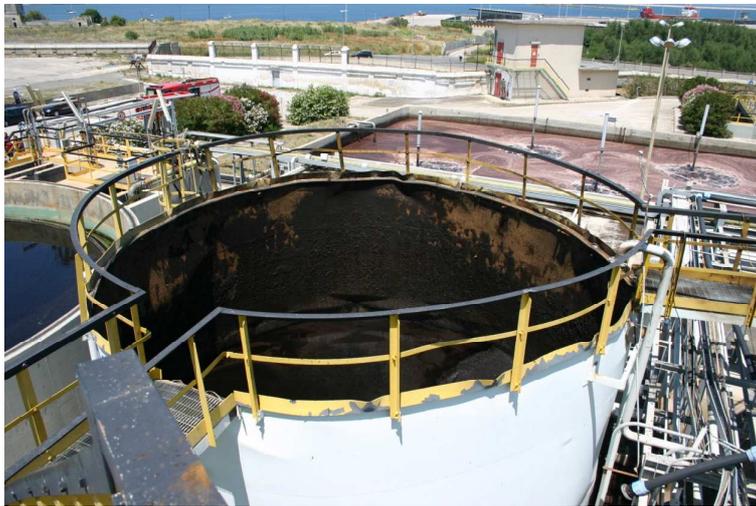
Fig. 7: Exploded TKX (source: ARPA Puglia)

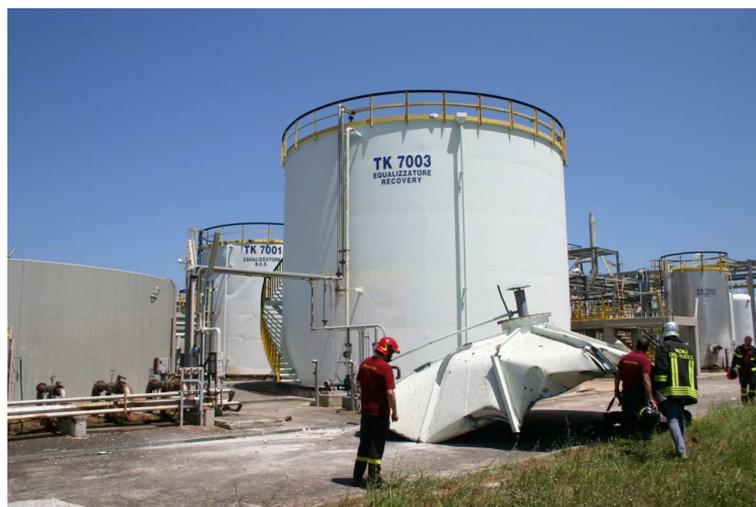
Fig. 8: Projected roof at the foot of the TKX (source: ARPA Puglia)

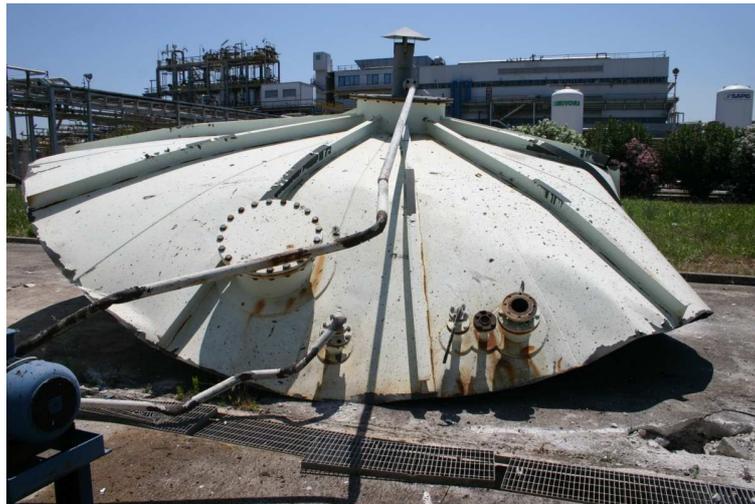
Fig. 9: Exploded roof, note the absence of plain flange on the air line (source: ARPA Puglia)

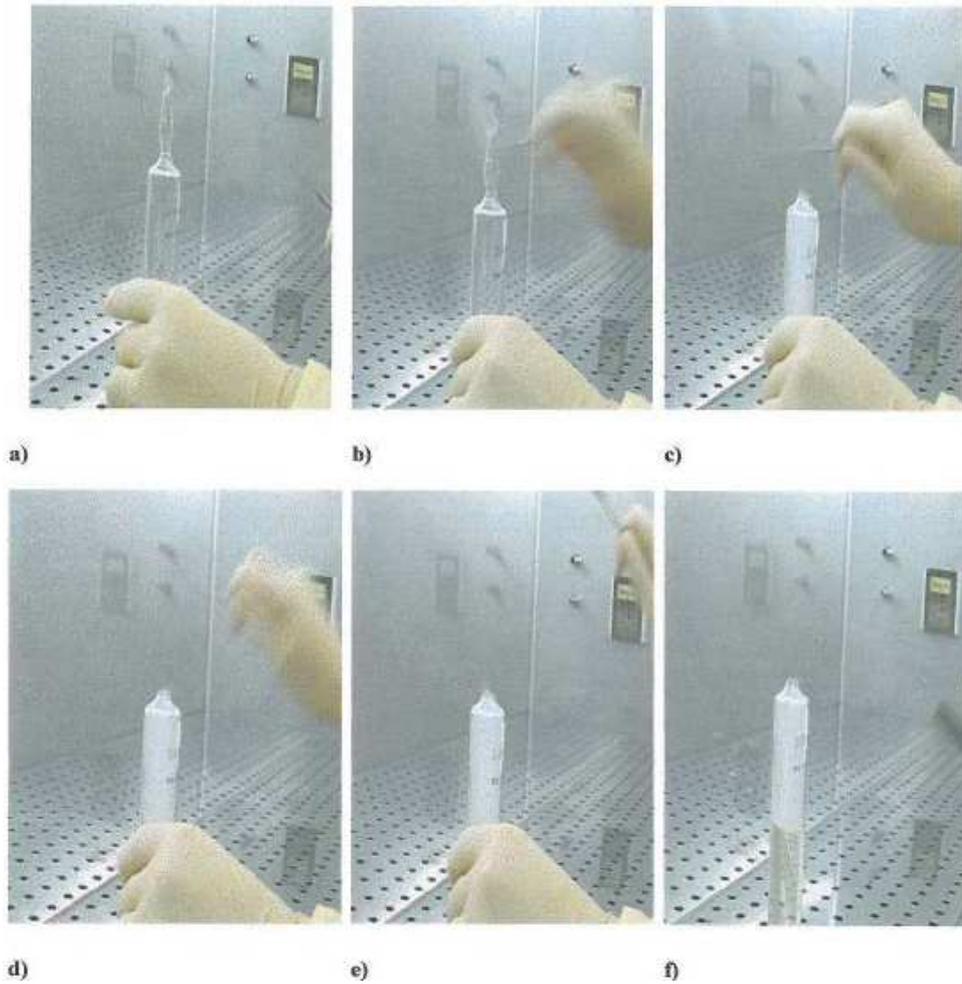
Gas-vapour phase: after the accident, BES samples were collected from the bottom of the tank. After an anaerobic fermentation in sealed ampoules, a gas-chromatography identification of gases formed was done. A high pressure had developed inside the ampoules, and some of them exploded due to overpressure after three weeks (Figure 10). The gas analysis confirmed the presence of traces of methane (CH<sub>4</sub>), hydrogen (H<sub>2</sub>), methanethiol (CH<sub>3</sub>SH) and flammable sulphides compounds, probably formed from the solid phase accumulated at the bottom of the tank in the absence of aeration system.

Fig. 10: Gas overpressure after anaerobic fermentation in sealed BES samples ampoules (source: ARPA Puglia)

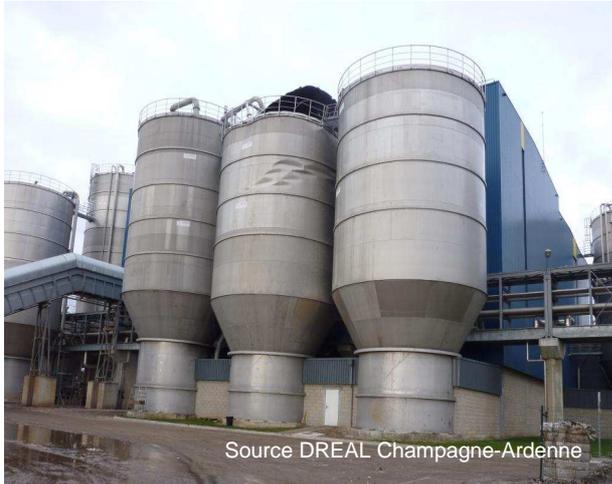
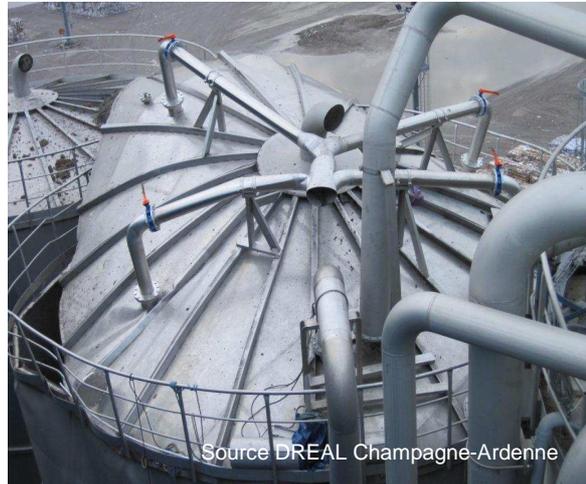
As for property loss, the LF storage tower sustained heavy damage and its use was immediately prohibited by the Inspection Authorities for Classified Facilities. This decision led to a production shutdown, as the tank involved was critical to factory operations.

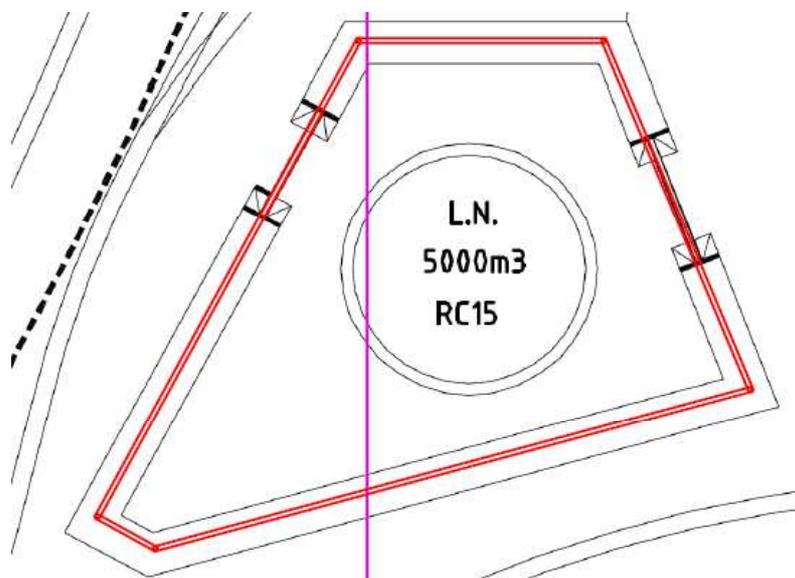
The tank and the retention basin

The wave effect of this sudden spill caused the collapse of most of the retaining bund walls. This wave, which started out 10 m high, spread across the site destroying installations, yet without triggering a secondary accident.

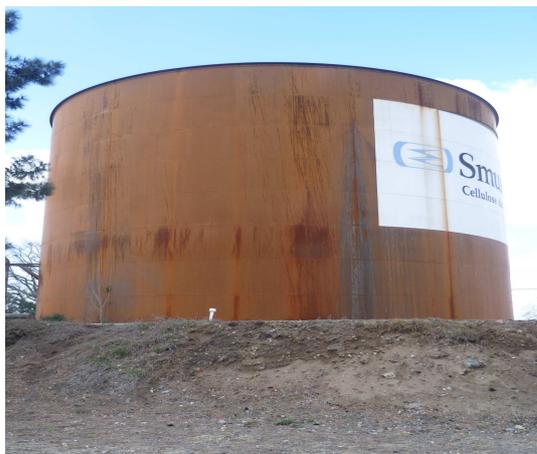
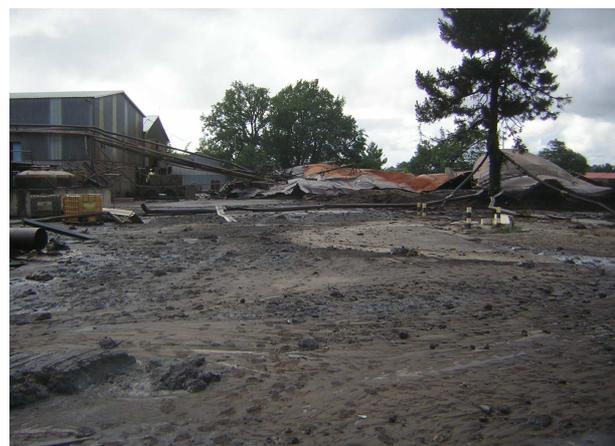
Photographs of the tank taken before and after the accident - Source: DREAL Aquitaine (Environmental Agency)

On 5 July 2012 at 2:28 pm, a complete rupture on the RC15 tank sidewall (a vertical zip tear) as well as on both the top joint (beneath the lid) and bottom joint (base of the chest) caused 4,100 m<sup>3</sup> of black liquor to spill at approx. 80°C inside the site boundary. A portion of this discharge reached the Lacanau stream and ultimately the Leyre River.

The expert commissioned by the factory operator reported that an instantaneous pressure surge caused an immediate opening of the tank at both the top and bottom, along with a "vertical zip" type of tear. This instantaneous pressure surge would have been triggered by a shockwave whose origin has yet to be determined.

An initial metallurgical appraisal of the damaged tank was assigned to the Classified Facilities Inspectorate by the gendarmerie. The content of this appraisal mainly focused on openings with crack lips observed on the tank. The break was exhibited by a "vertical zip-like" tear crossing metal sheets without following any weld lines, offset in a step-like pattern between each sheet. The appraisal also uncovered local buckling and the presence of a lower-quality steel.

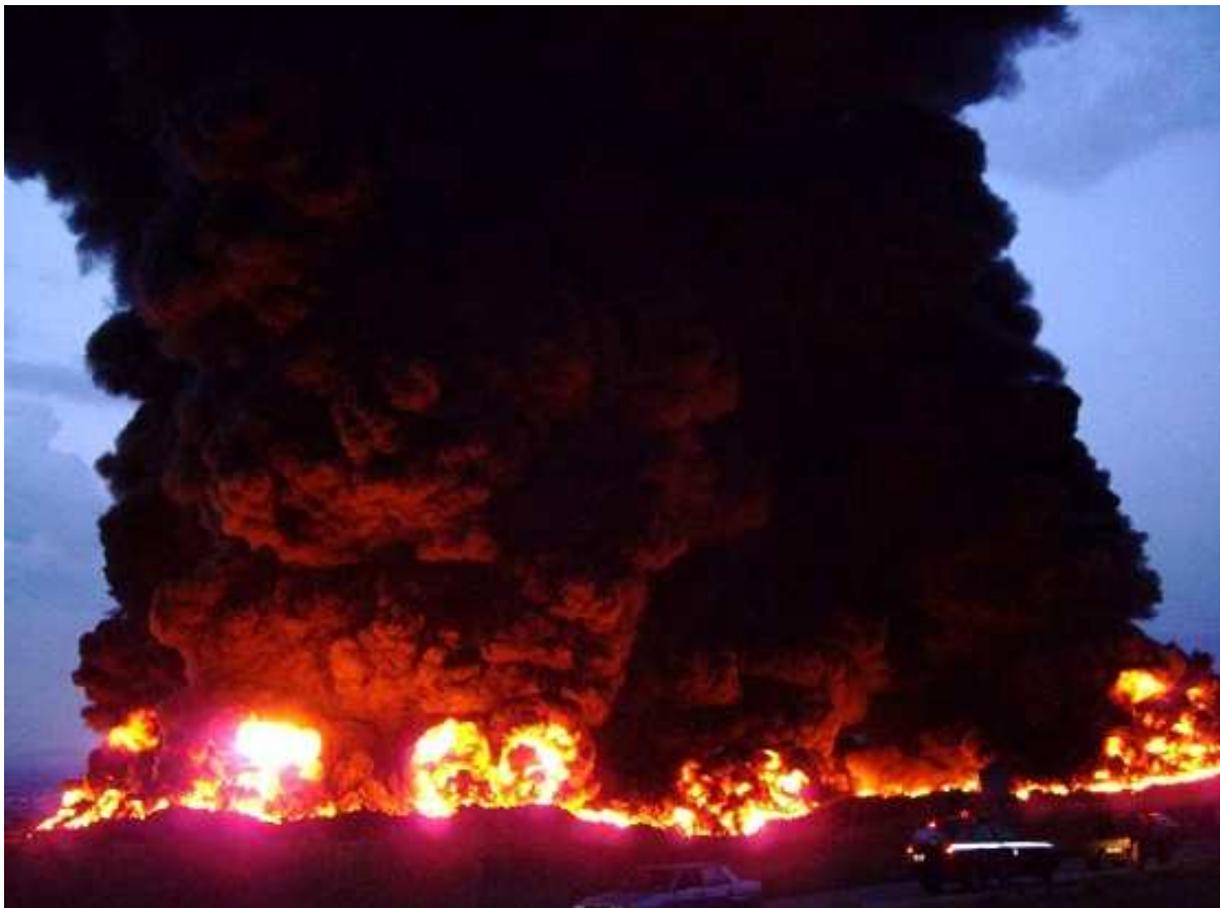
The first fire-brigade vehicle arrived on site at 02:20 am, but the fire had already expanded to most of the pile. Back-up forces had to be called and fire quenching with water and foam begun, which continued until morning. In all, 15 fire-engines and 50 fire-fighters from Drama and the neighbouring cities were involved on the first day, but quenching efforts with water and foam proved to be ineffective.

*The blazing pile during the first hours (photo taken by the Institute of Geology and Mineral Exploration)*

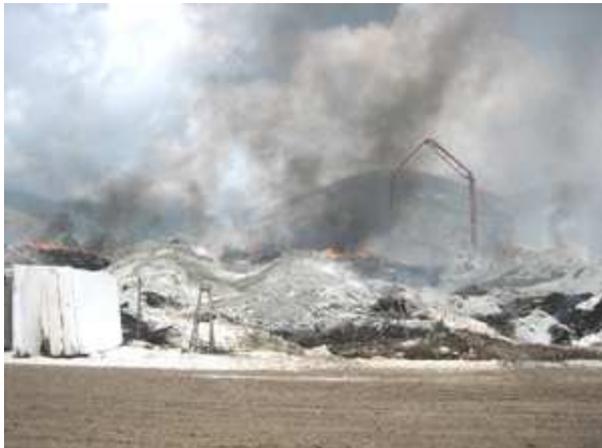
*Concrete being pumped on the burning pile.*

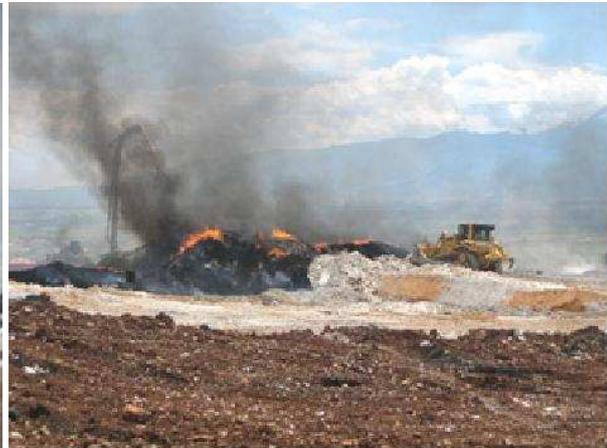
Owing to the immediate and massive fire-fighting efforts, the burning pile was completely covered with soil after 3 days. Though smoke was no more visible, rubber pyrolysis continued within the pile for days. Fire-fighters thus remained in the area, in case of revival.

*Burning pile being covered with soil.*
